**Re: Davis- Thayer Existing Conditions Report – March 21, 2023**

# DAVIS THAYER ELEMENTARY SCHOOL

## EXISTING CONDITIONS REPORT

March 21, 2023

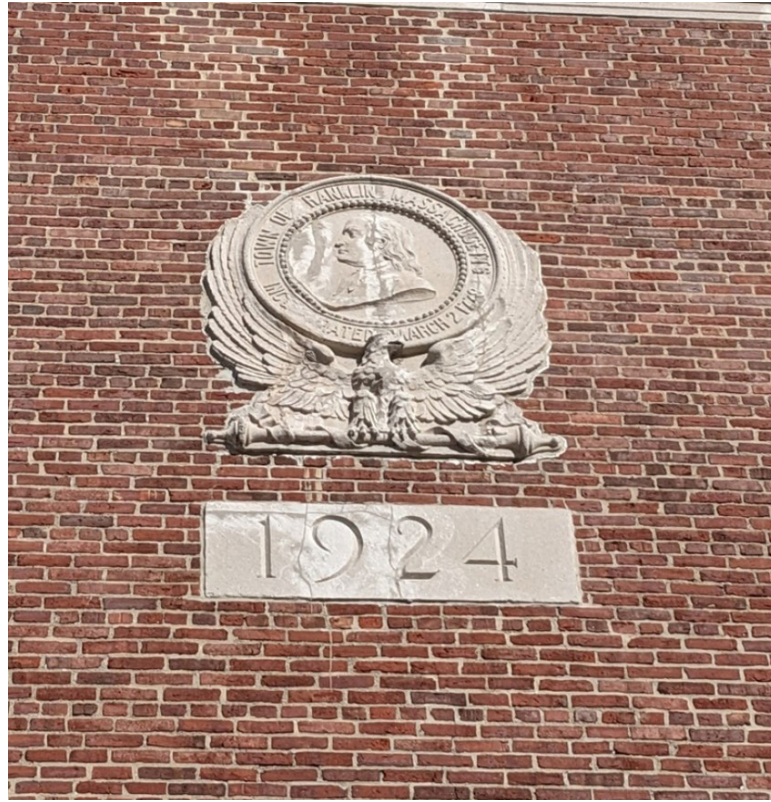
Figure 1 – Original Building Constructed in 1924

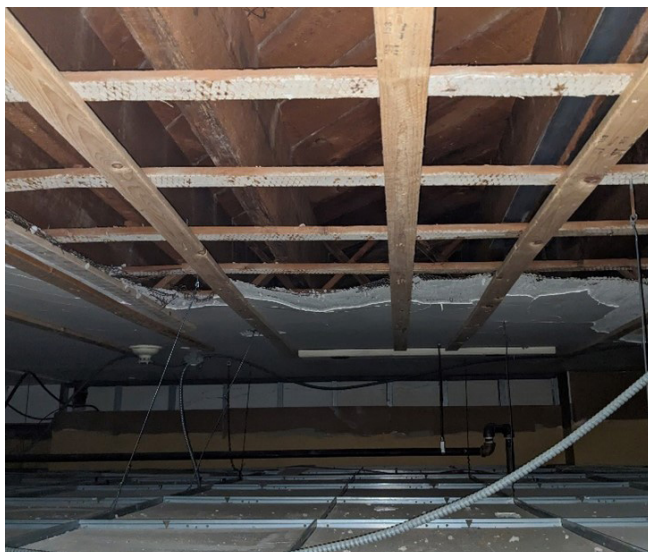
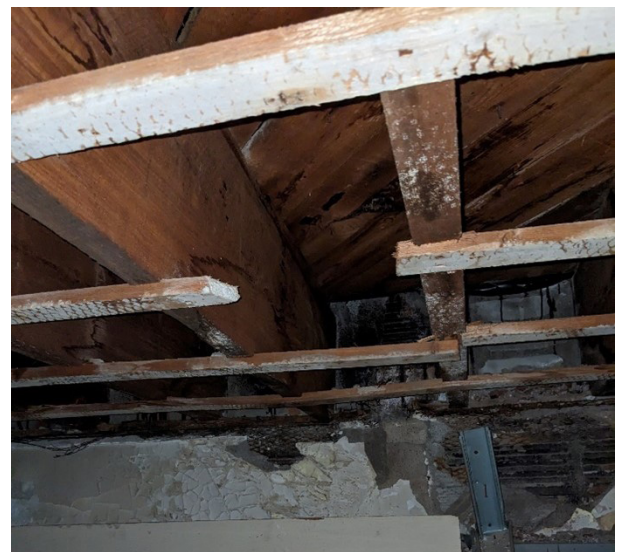
Figure 2 – Wood Framing Below Second Floor Classrooms

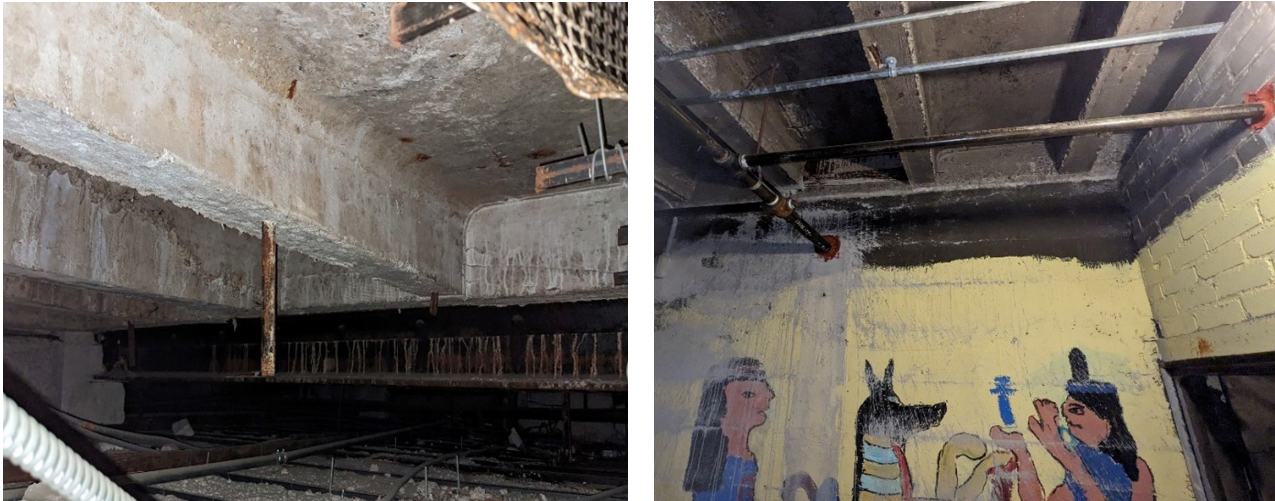
Figure 3 – Reinforced concrete rib-slab construction above kitchen and lower-level storage.

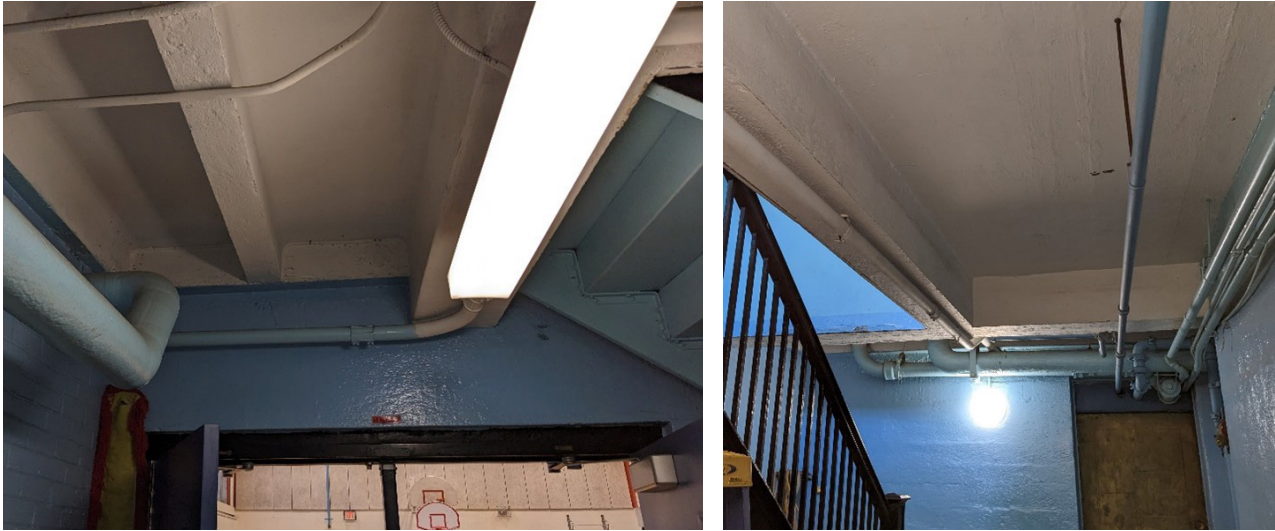
Figure 4 – Reinforced concrete beams and slab construction in stairwells.

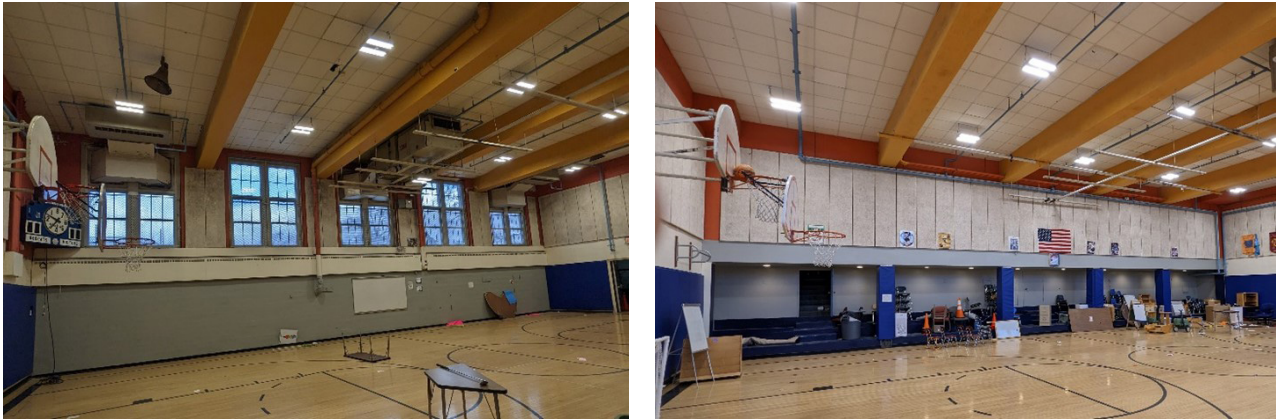
Figure 7 – Existing gymnasium one-half story below exterior grade.

The Gym is undersized and does not provide a full size basketball court. There is minimal space beyond the sidelines of the court and no space beyond the endlines to the masonry walls and this presents a hazard to players on the court. Wall pads are provided on the endwalls but not the sidewalls or the bleachers. Storage space for gym equipment is not available and a gym teacher's office is not provided. There is a cast iron roof drain leader mounted on the sidewall which exits through the wall at about 5 feet above the floor; this is a severe hazard for students and players using the court.

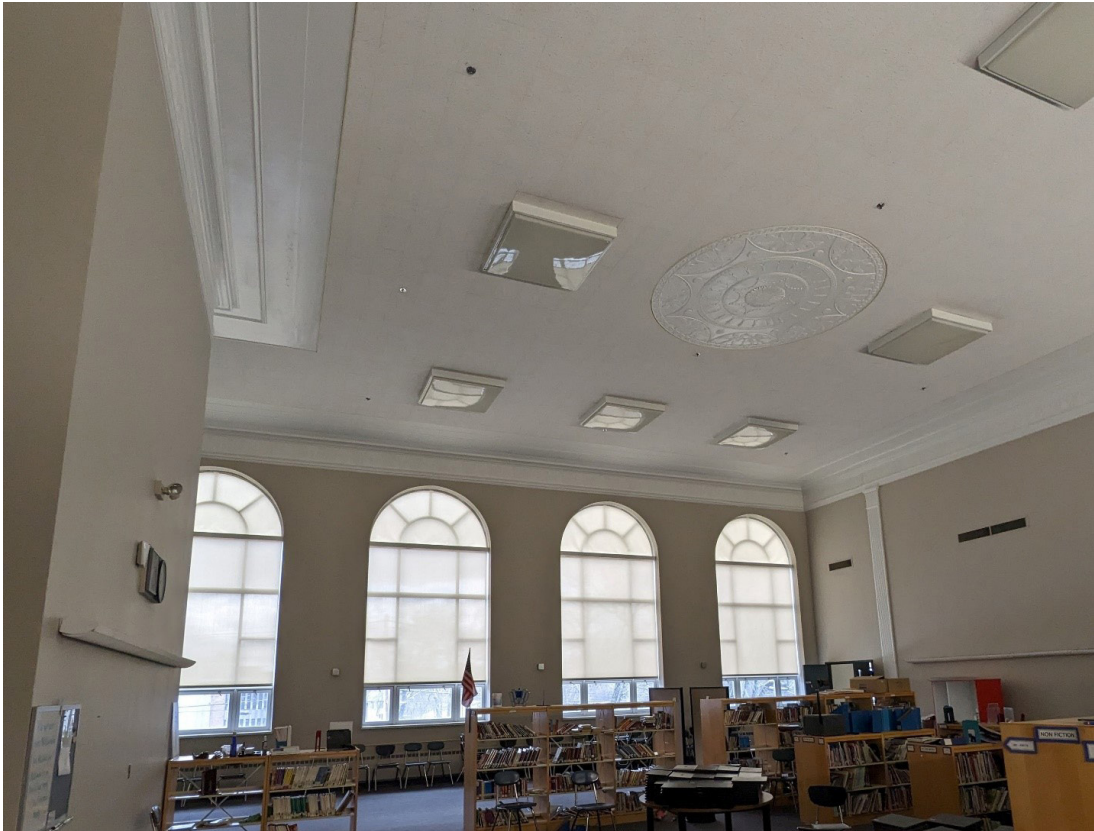
Figure 8 – Two-story library structure

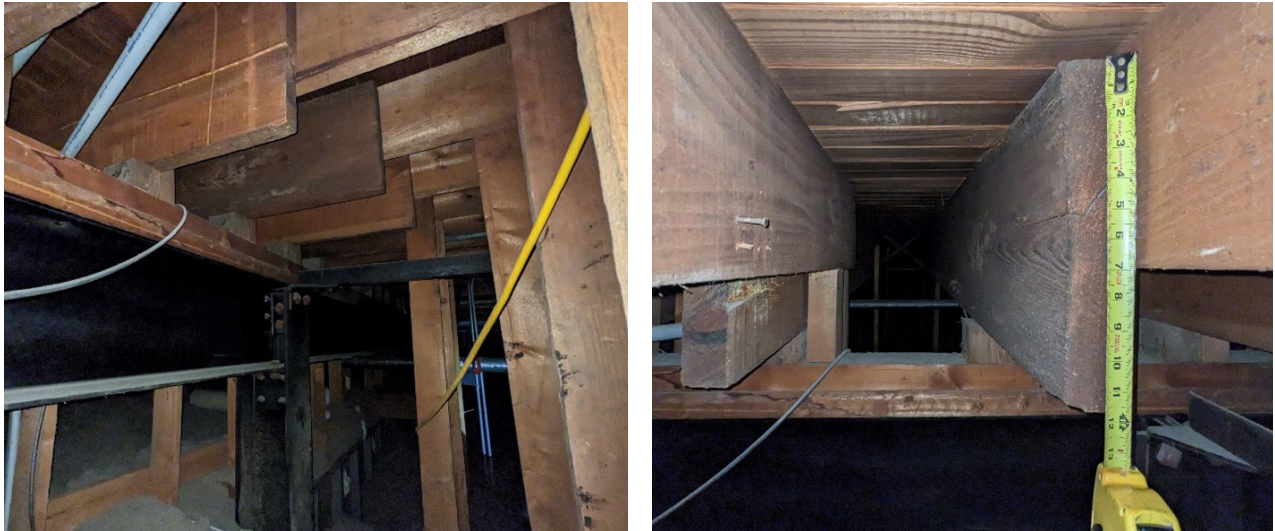
Figure 9 – Attic photos showing steel beam, column, and wood roof framing

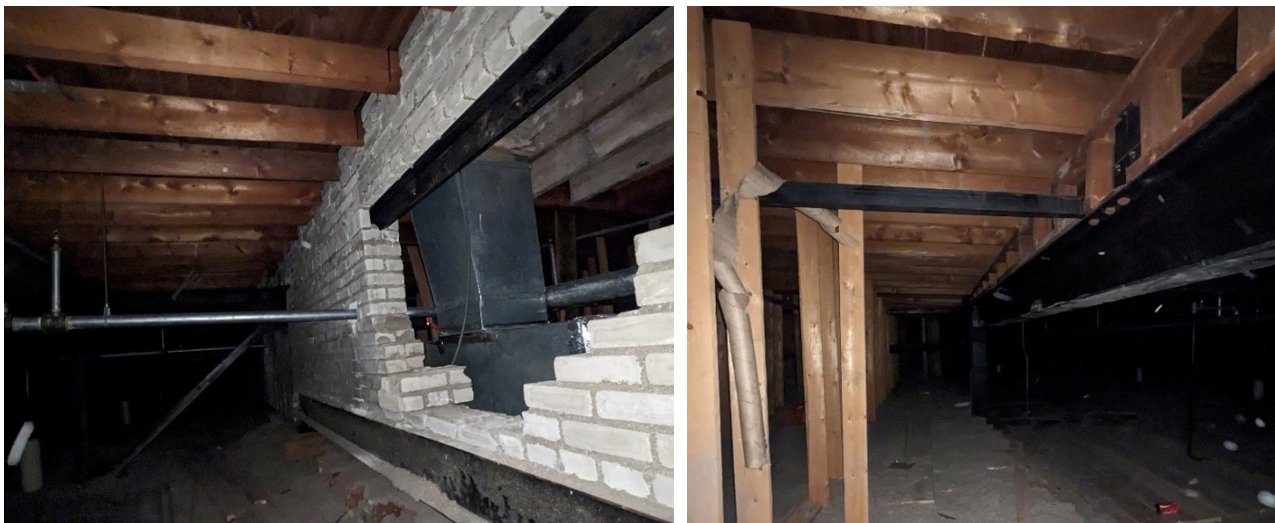
Figure 10 – Steel truss roof framing over library area, and cripple walls providing pitched roof construction.

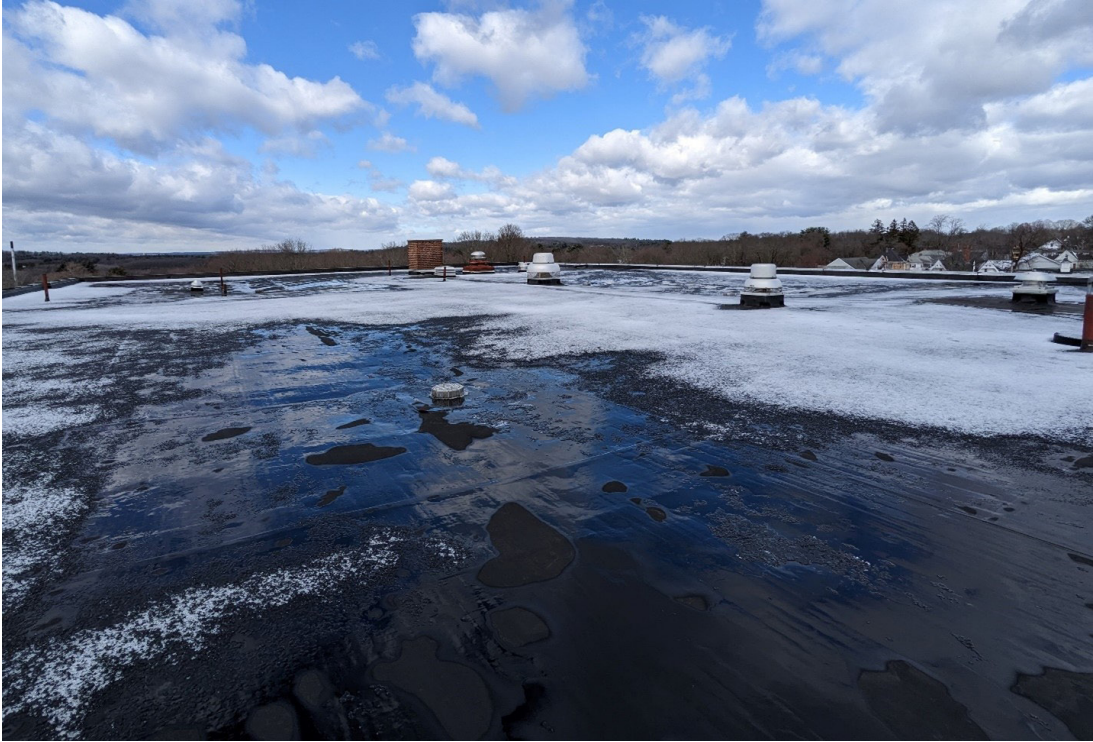
Figure 11 – Photo showing roof properly pitched to roof drains, and limited roof top equipment.

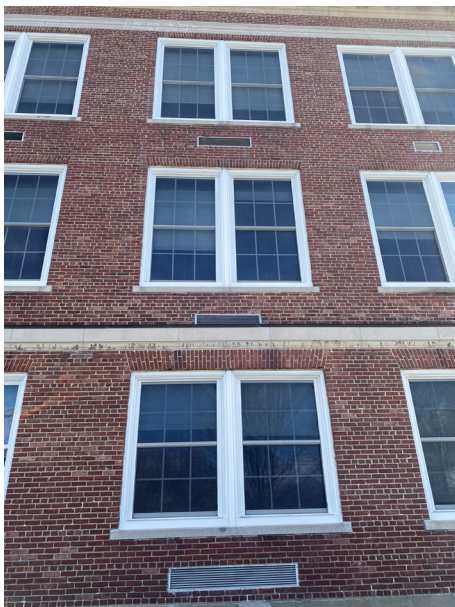
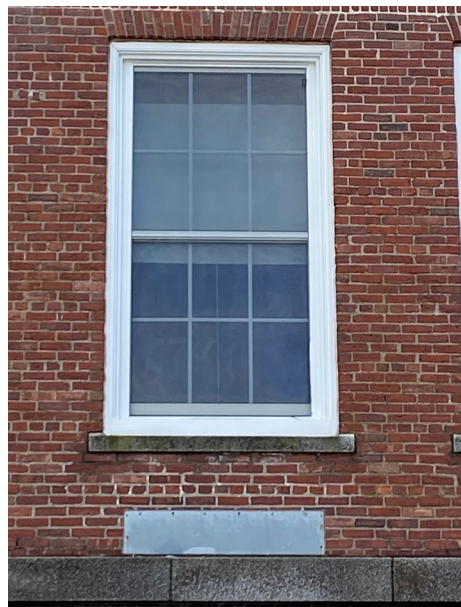
On the north side of the building, the 1973 renovation modified a row of windows to become doors leading to a fire escape. The fire escape was demolished at least 10 years ago but the doors remain and are a life safety hazard. These doors should be removed and infilled with with brick and backup CMU to match the existing construction with new windows.

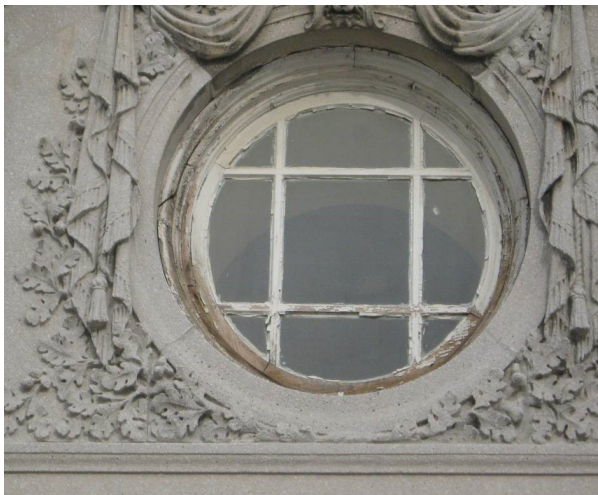
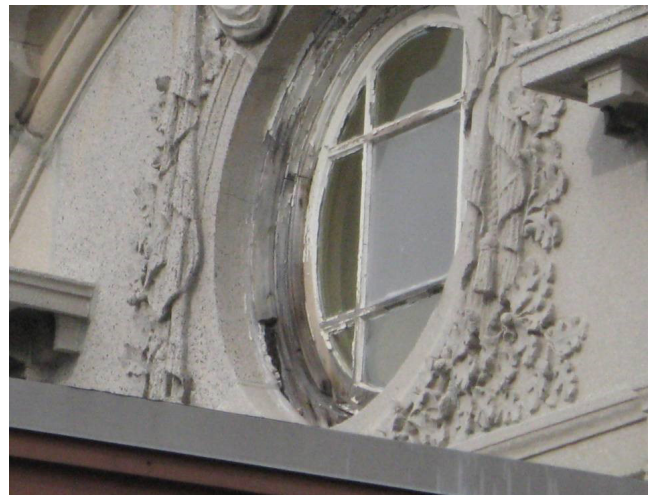
At exterior windows, there is evidence of water infiltration. For example, the plastic laminate interior window sills at the Media Center space on the north side of the building is peeling from the substrate presumably from water damage. All windows should be resealed with caulking.

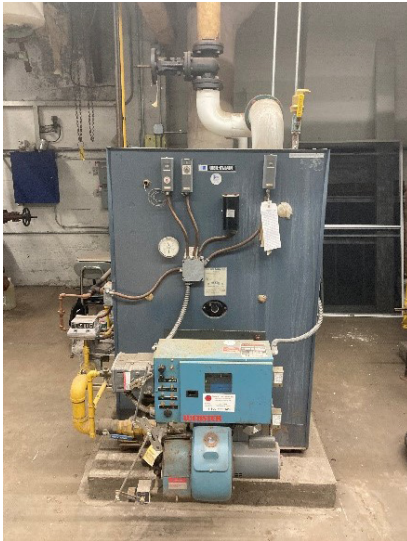
The building is served by a central gas fired gravity vented boiler plant located in the basement mechanical room. Two 2,049 MBH input Weil McLain Model 88 cast iron hot water boilers with gas fired burners were installed in 1996. The boilers feed hot water via a central pumping supply and return piping system to all unit ventilators, cabinet heaters, unit heaters, air handlers and perimeter radiation.

Boiler, Front View

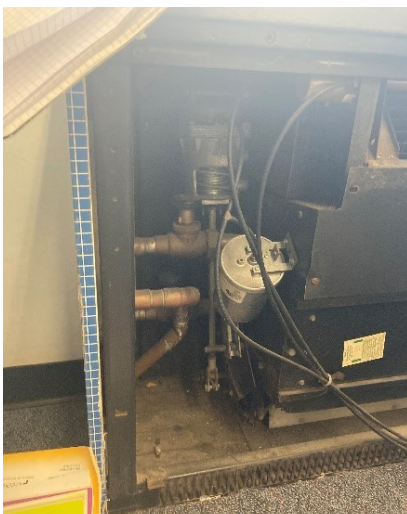
Typ. Heating UV, note piping and pneumatics

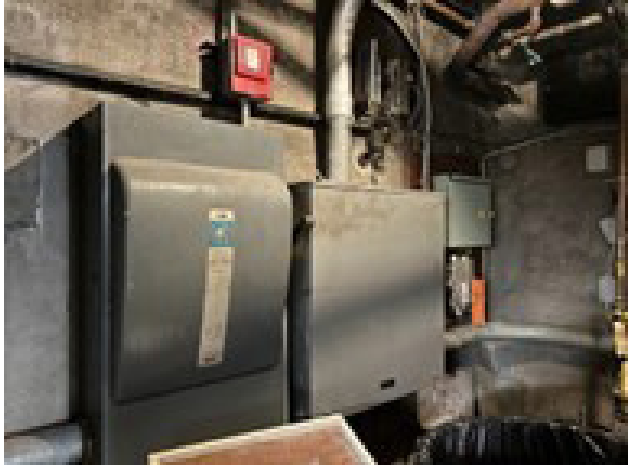
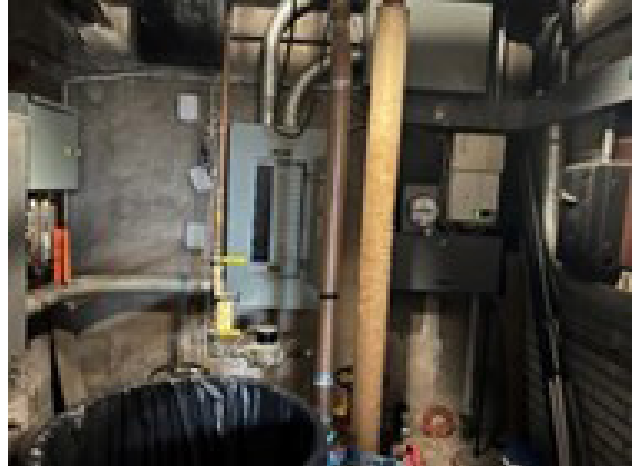
The building is fed via overhead electrical service from pole mounted utility company transformer to a 400 Amp, 208V/120V, 3-phase, 4-wire service entrance disconnect switch manufactured by Bulldog and main distribution board located in the basement electric room. Secondary utility metering is provided. Access to the main distribution board is obstructed by the water service entrance assembly equipment. Branch panel boards manufactured by Westinghouse, Kelek and Square D appear to be in fair condition with minimal spare/space for future capacity.

Power is distributed to branch panelboards located in electric closets at the 2nd and 3rd floor. Flush mounted panels are located in the 1st floor cafeteria. There is no spare/space for future expansion. In addition, it was noted that the dedicated workspace clearance has not been provided in the 3rd floor electric room as required by NEC Article 110.26.

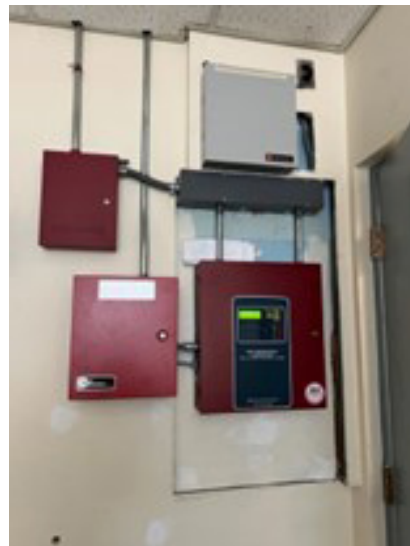
The fire alarm system control panel is located in the Nurse's Office at the main level. The fire alarm control panel is manufactured by Firelite/Honeywell and appears to be relatively new. Notification appliances (horn/strobes) have been provided along egress paths. Minimal coverage has been provided in the library and cafeteria. No coverage has been provided in the restrooms. Devices appear to be in good condition and meet current ADA requirements. The initiating devices (smoke detectors, pullstations, etc) appear to be a combination of new and original. It was noted that 100% smoke detector coverage has been provided in the corridors to supplement the sprinkler system.

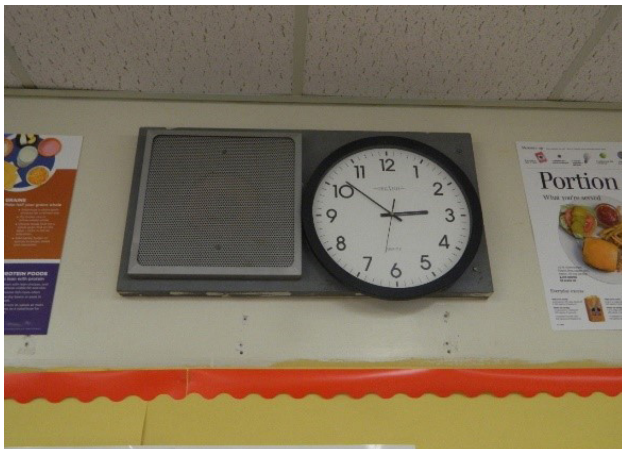
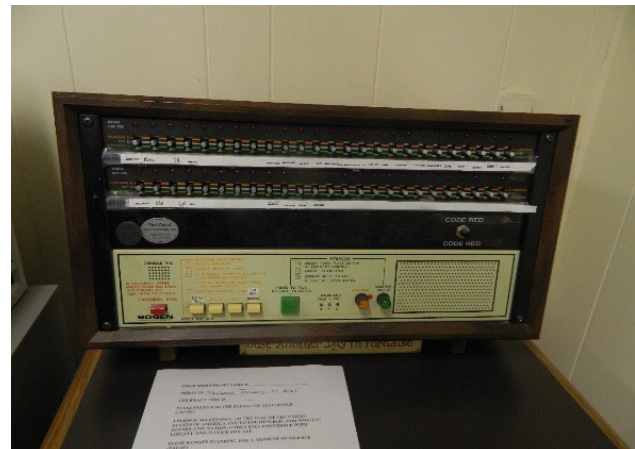
The existing PA system was provided as part of a building upgrade prior to the 1972 project. Many of the clock/speaker assemblies are not operational and have been modified with independent speakers and wall clocks.

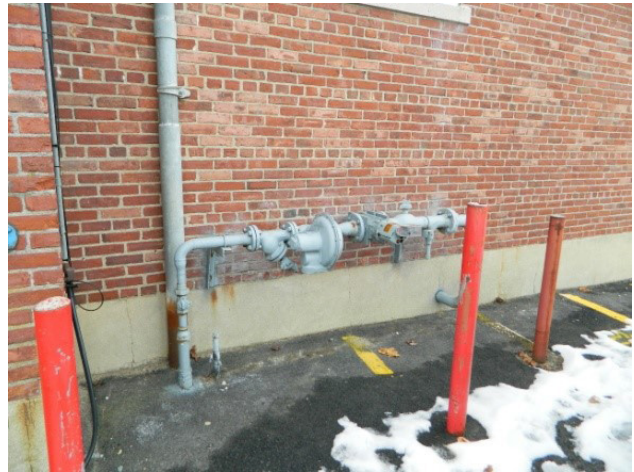
A three inch (3") natural gas main enters the basement mechanical room adjacent to the entrance stair from the exterior location of the gas service, utility meter and regulator. The line runs horizontally along the mechanical room ceiling and drops to the gas fired boilers and domestic hot water boiler. The gas main is fed from the gas service main located in Union Street. The natural gas distribution piping appears to be in very good condition. The existing gas service will need to be coordinated with the gas utility provider to determine if the existing main and pressure is adequate to supply the proposed new gas requirements of the school fit out plans.

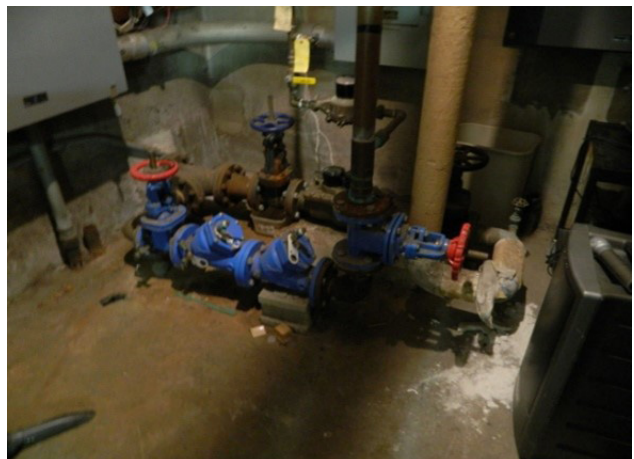
The domestic water service main (3") enters the shared Electric / Water (This is a potential code violation if any modifications or upgrades are required in the future buildout) service room 147 thru the concrete wall and transitions above the floor to a tee (this tee valve looks original and dated) and horizontal piping serving three discipline.

The domestic water piping is fully insulated from the outlet flange of the shut off valve downstream of the water meter. The fiberglass all service jacket insulation appears to be in fair to good condition. There is a damaged insulated elbow at the base of the riser that appears to be the original insulation that has been damaged. There is a powdery material on the floor below the damage that should be tested for asbestos content. There are labels at the distribution tunnels below the school indicating asbestos materials beyond.

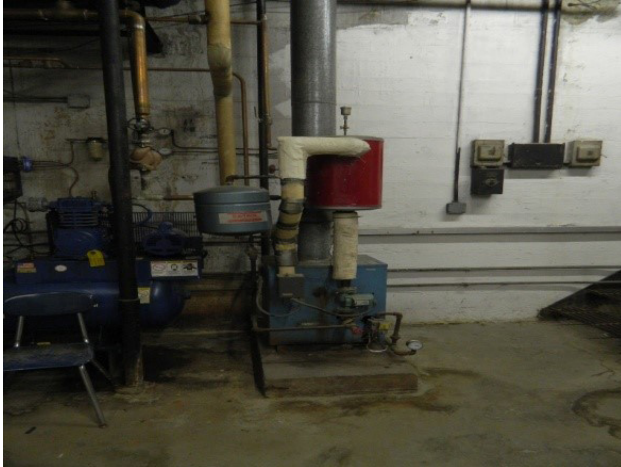
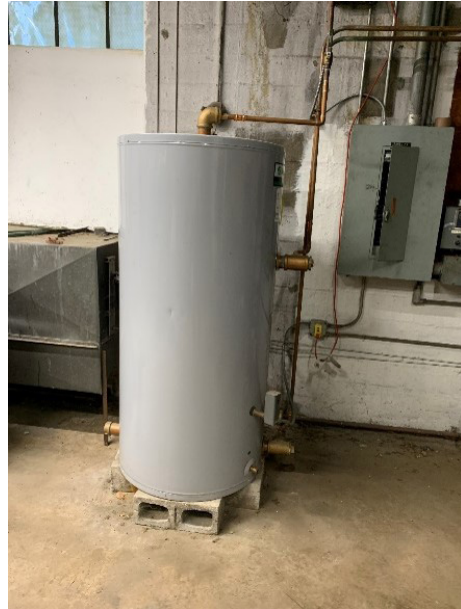
Domestic hot water is generated via a Burnham 50,000 btuh gas fired gravity flue type boiler (This boiler system looked aged) located in the basement Mechanical Room 144.

There is a new looking A.O. Smith, model TJV120M, 119 gallon storage tank installed recently and existing hot water circulation system located in the basement Mechanical Room 144.

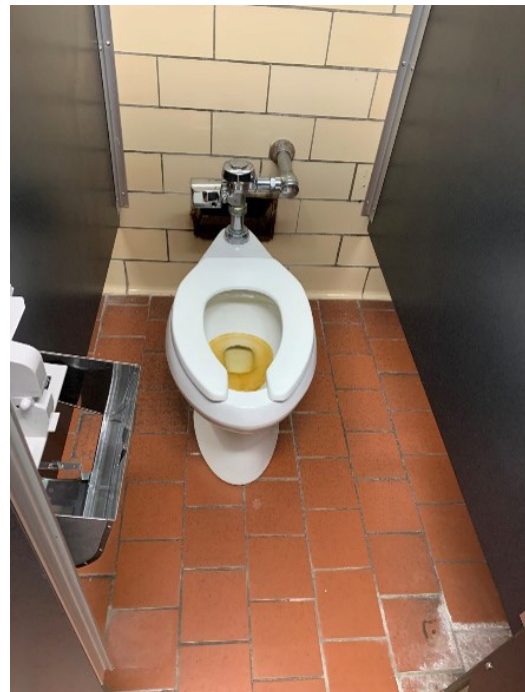
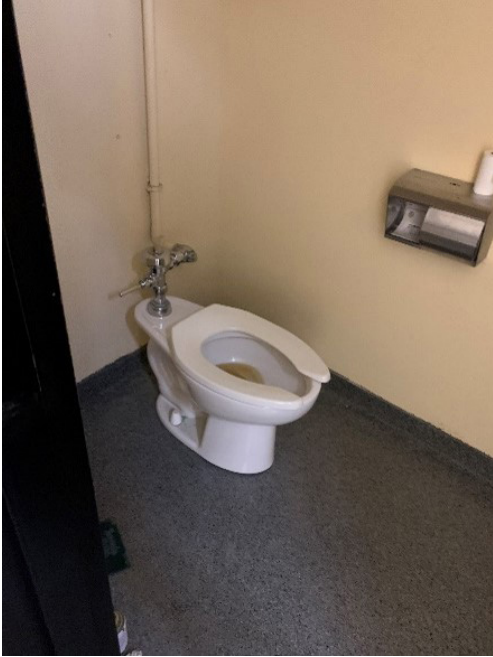
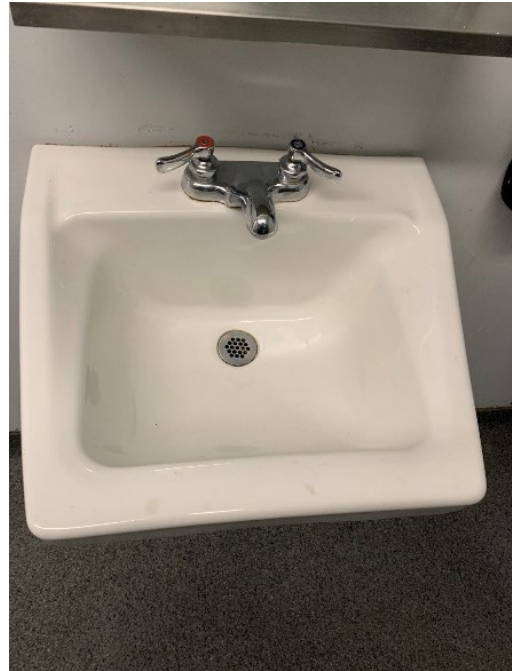
The toilet room fixtures are aged, stained and not all fully functional and most likely non code compliant. Full ADA accessibility will be determined by the architect. The urinals and water closets incorporate both manual and electronic sensor operated flush valves while the lavatories use 4" centerset conventional manual handle controlled faucets. There are some locations where the lav faucets have been updated with newer electronic sensor faucets as well. Some of the lavatories have been replaced with wheelchair type lavatories, but lack proper mounting height, clearance and insulation kits to be considered ADA or Massachusetts Architectural Access Barriers Board accessible compliant fixtures. All fixtures are in poor to good condition. There are water closets with wide stalls that have manual flush valves mounted on the wrong side, lacking proper clearance and grab bars to be considered accessible. There have been numerous fixture and fitting replacements over the years for upkeep and maintenance. The existing floor drains within the toilet rooms require replacement grids or trap primer connections to be code compliant and it is not clear at this time if they were the originally installed drains or replacements.

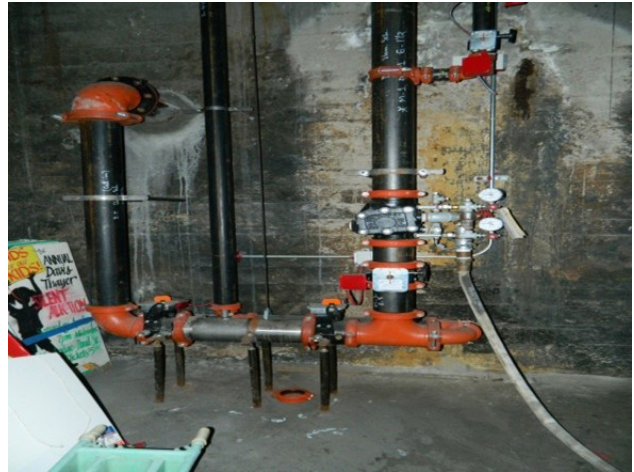
Located within the basement general storage room 143 is a single 8" fire protection service main entrance. The fire protection service main enters the room through the foundation wall and transitions through an 8" elbow with a 6" reducing flange, drops and horizontally offsets above the floor to a floor mounted double check valve assembly and main system wet alarm riser valve. The system serves the school's combined standpipe riser, standpipe riser, wet fire protection system and remote located dry alarm riser valve located on the third floor. The dry alarm system riser assembly is located in the Teacher Toilet Room 321. The dry system feeds the attic and library dry sprinkler system. The existing old fire protection service located off of the existing domestic water service located in Water/Electric Room 147 at the basement, is still connected with a double check valve assembly. The system is currently valved off. The new system was installed in 2007 and appears to be in good working condition.

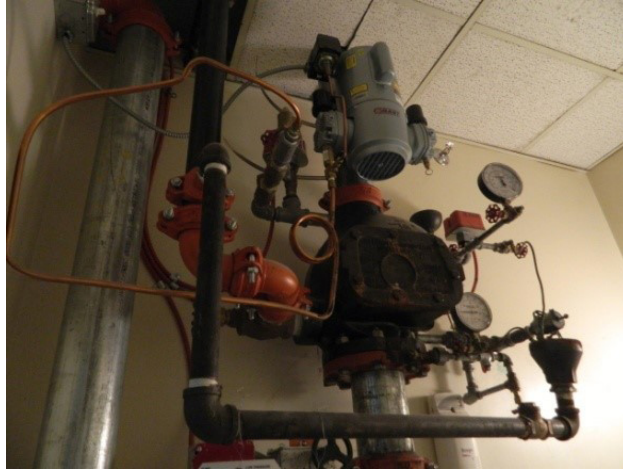
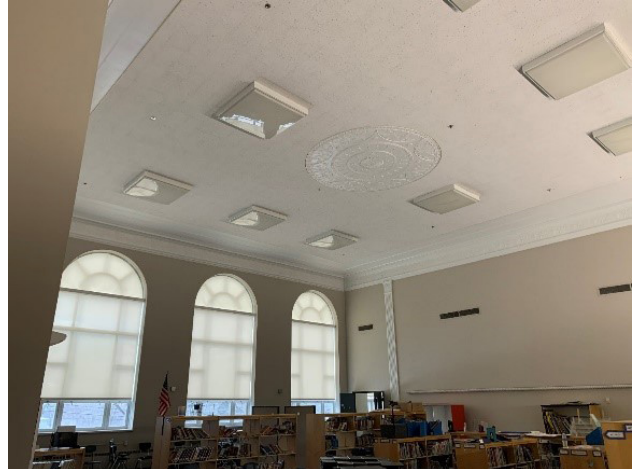
The Attic and Library areas is protected with a dry sprinkler system throughout and is protected with a combination of exposed piping with upright heads. There is a suspended acoustical ceiling tile plenum located below the original third floor ceiling in the corridors and classrooms. The Media Center 304 has the original ornamental wood trimmed ceiling with dry sprinkler system.

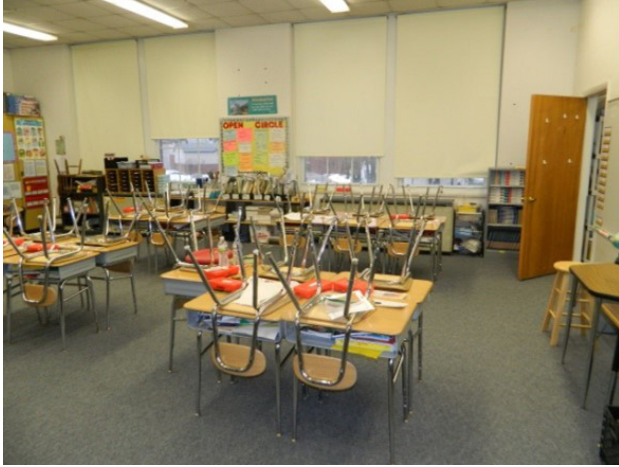
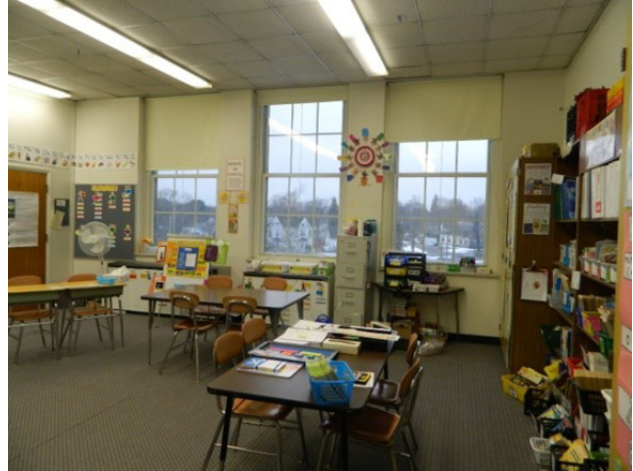
A full coverage wet sprinkler system is installed that covers the three floors of the building. Recessed pendant heads are installed in the suspended acoustical ceiling tiles with concealed piping located above the ceiling. The original plaster ceilings are located in their original condition above the suspended acoustical ceiling and protect the wood framed construction.

Sprinkler coverage was noted as providing full coverage for this building.

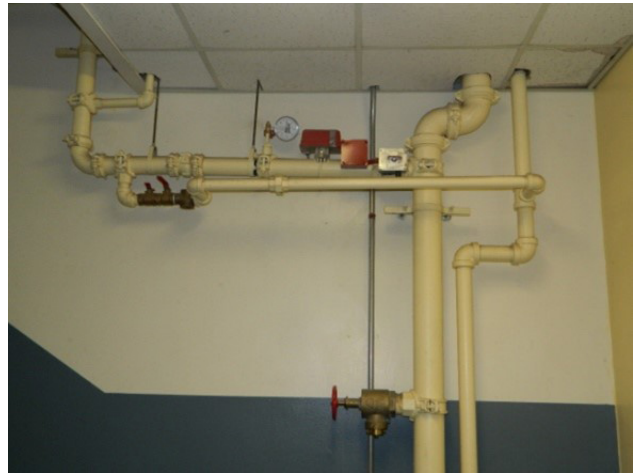
Class 1 combined standpipe with hose valves and floor control valves is located in the main stair 279 and a Class 1 standpipe with hose valves is located in other stair near the administrative offices. Egress stairs are compliant and the standpipe system and combined standpipe will be utilized to serve the defined sprinkler zones identified in the overall building study with the existing floor control assemblies.
