STUDY FOR THE

DAVIS THAYER ELEMENTARY SCHOOL

FRANKLIN, MASSACHUSETTS
MAY 31, 2013

KAESTLE BOOS
associates, inc

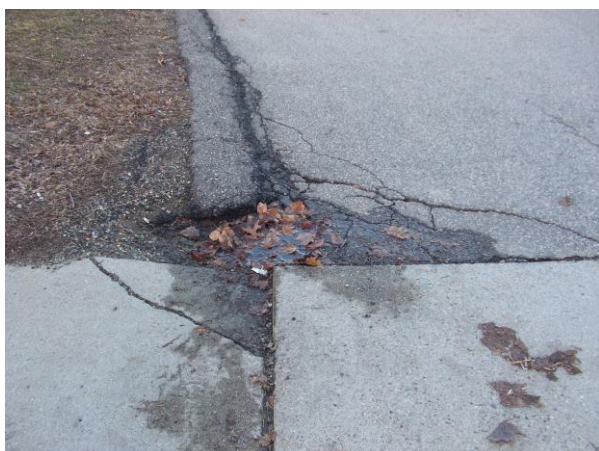
The asphalt parking spaces and driveways are in varying states of repair. Some asphalt, such as the new stacking area along the lawn play area, is relatively new. Other sections are older, with evident cracking and signs of water damage. The asphalt has been recently been restriped. Several areas have been patched, particularly on the north side of the building where the paved play is located. This paved play is striped for hopscotch, four square and crosswalk striping to the athletic fields from the three exits from the building.

Water damage at Rte. 140

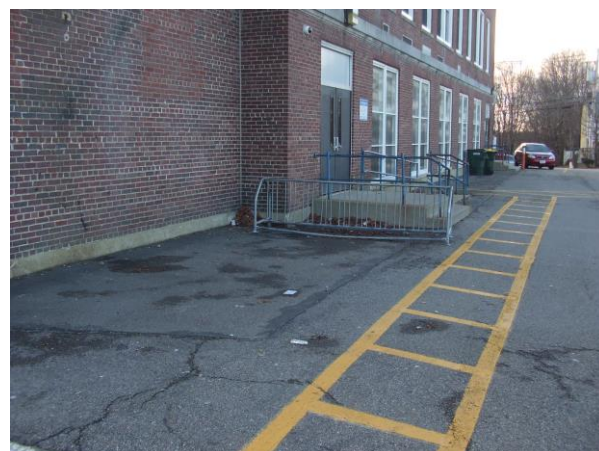
Patching and cracking north of the school

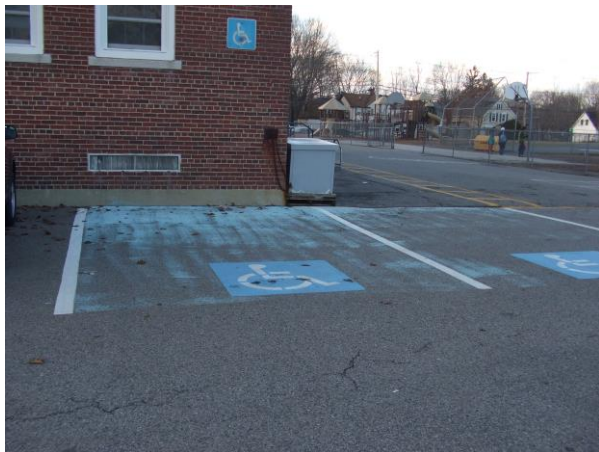
ADA parking on site consists of two wide parking spaces, at one time painted blue overall, but now with only a blue square for the HC symbol. These are non-compliant due to missing striping, incorrect signage and no designated loading zone. Per the 60 parking spaces on site, a total of 3 ADA spaces are required by law. The school is missing a passenger drop off area, (5' x 20') that would be normally striped and signed.

HC parking area

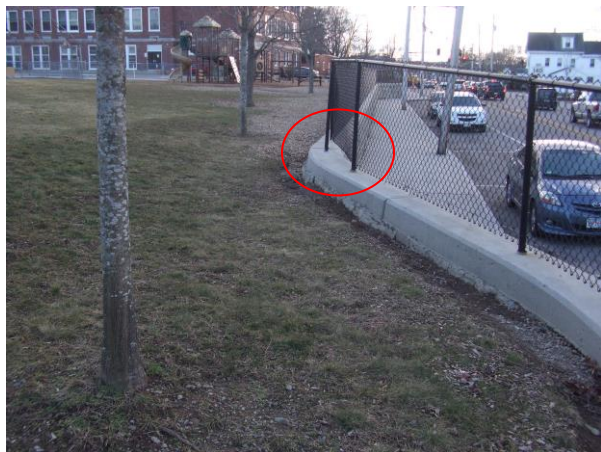
Fence on retaining wall, fabric pulling away

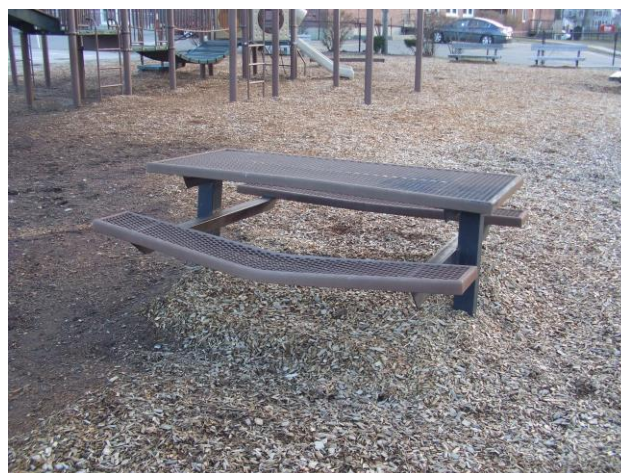
Damaged Picnic table

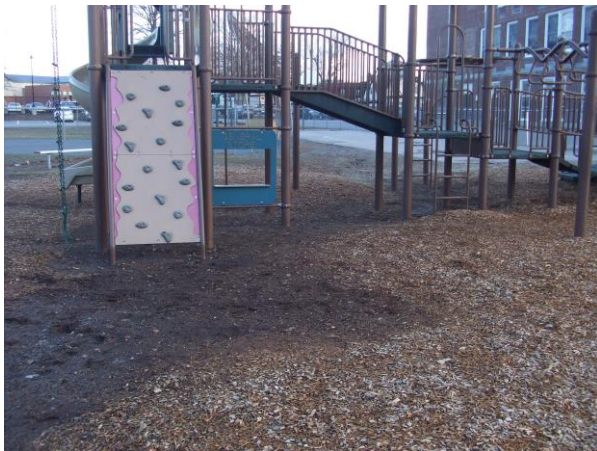
Drainage problems are mostly related to the playground where inadequate drainage in the stone dust infield and by the swings causes ponding and subsequently mud when the areas are subject to heavy foot traffic. Most of this water is due to sheet flow directly from the driveway /stacking area. A major drainage swale runs under the playscape, as mentioned previously, which drains to the rear of the retaining wall at Union Avenue. Not only is this swale removing large amounts of wood chips that are necessary for fall safety at the playground, it is also eroding the rear of the wall, exposing the rear façade and possibly subjecting it to failure in the future. There is a small erosion problem by the northwest corner of the Dean College parking lot, but this may be caused by overuse from students. This erosion has exposed chain link fence posts as well as the end of the retaining wall supporting the upper platform currently not used by the school. The majority of the south side of the school simply drains onto Rte. 140. No drainage system was observed on site, other than the drainage for the accessway to the basement on the west side of the school.

Drainage running under the play structure

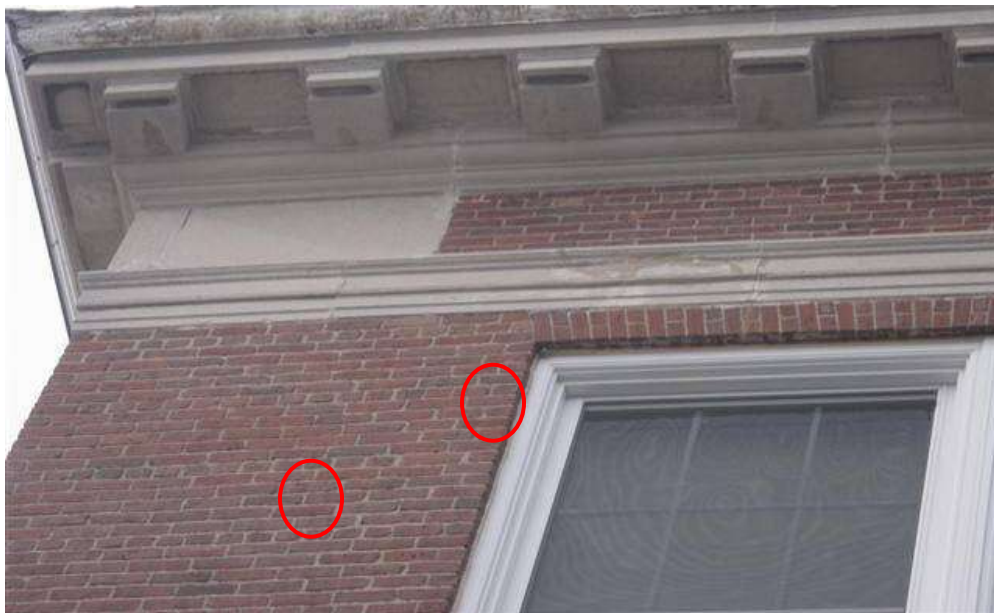
- The exterior masonry is exhibiting signs of considerable wear to the mortar joints. The mortar surface is rough from continual exposure to wind driven rain and age of the building. The course surface will allow water seepage into the joints which then is subjected to freeze/thaw cycles that causes spalling of the mortar and enables additional water to be absorbed by the masonry.

Spalled bricks

- The exterior brick wythe should be completely repointed which would include the routing of all mortar joints and replacement of all damaged bricks. At the same time as the repointing is occurring, all corroding lintels should be removed and replaced. This repair will require that the windows be temporarily removed to allow access to the steel angles. The flat arches and on course of brick must be removed to install the new hot dipped galvanized angles. Flashing, end dams and weep holes will be installed in the outer wythe brick wall above the new lintels.

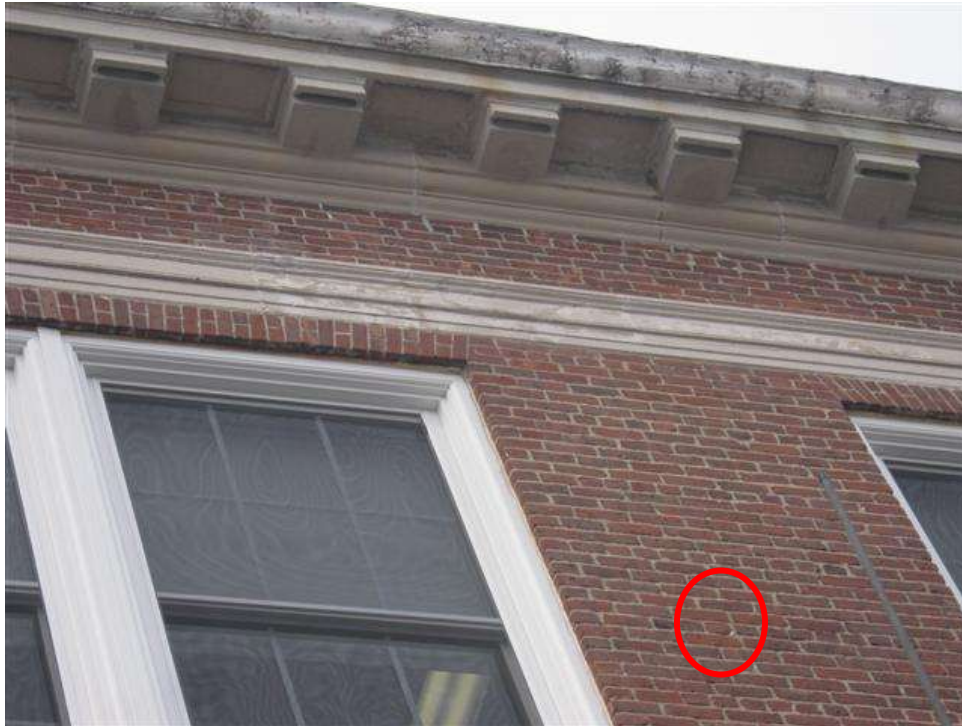
Isolated spalled brick faces

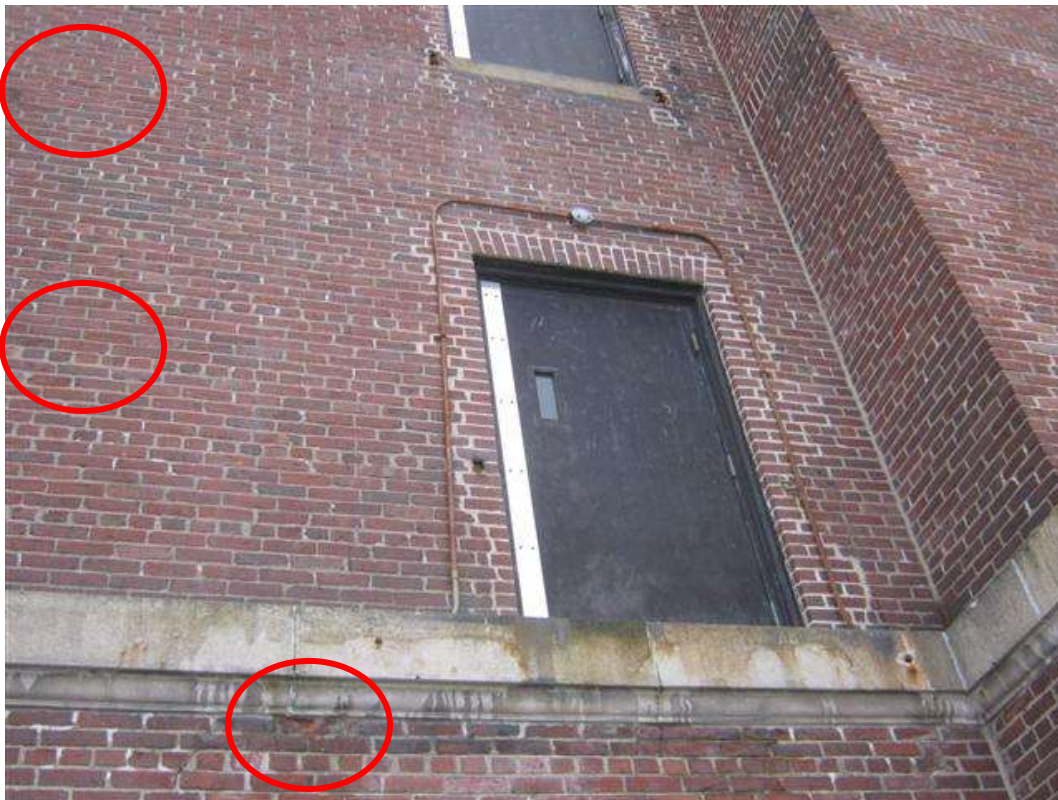
Isolated spalling brick on north face of building

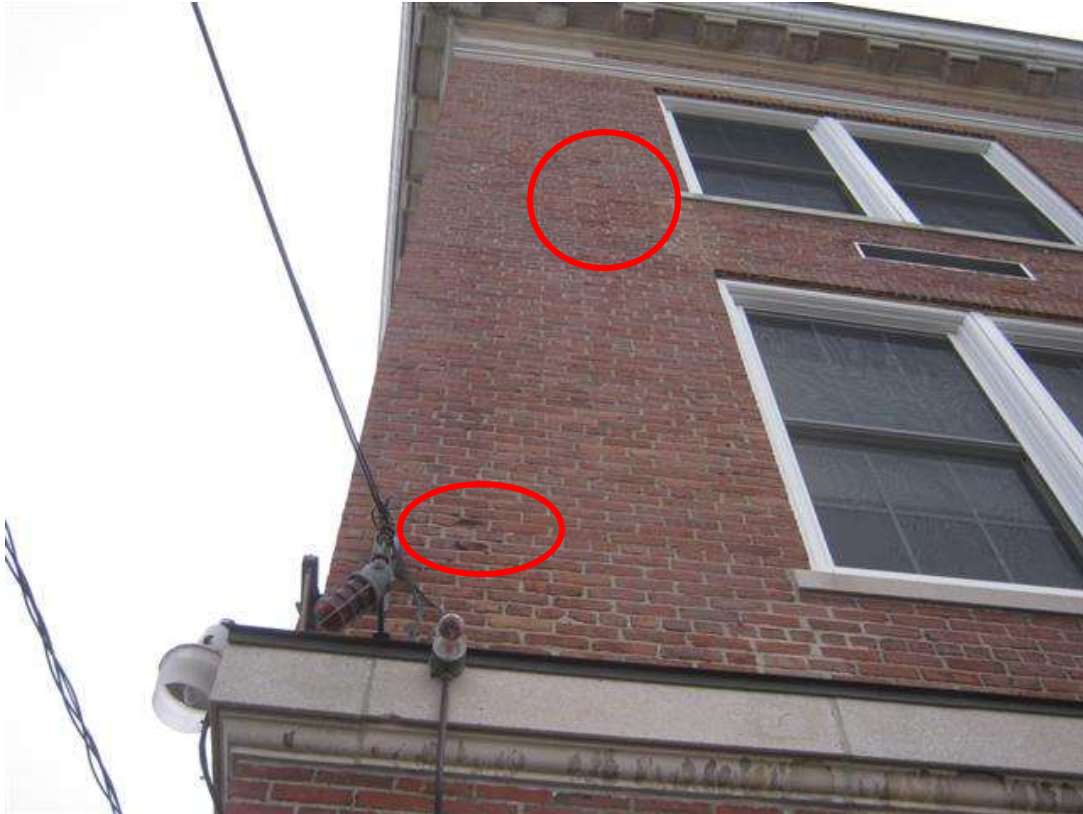
Spalling brick face

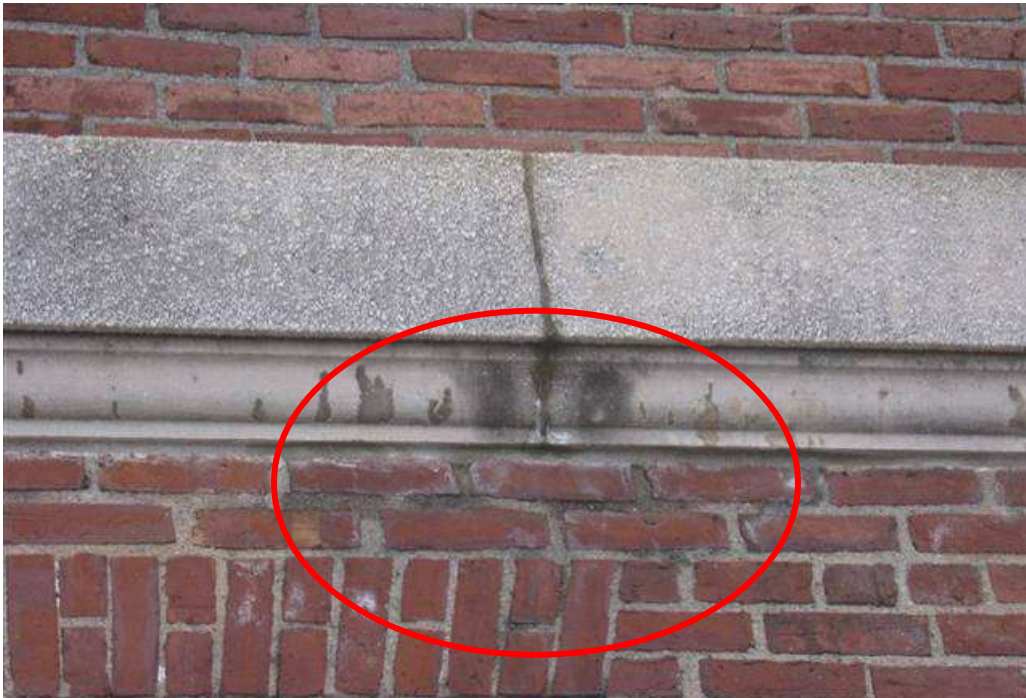
Spalling mortar joints

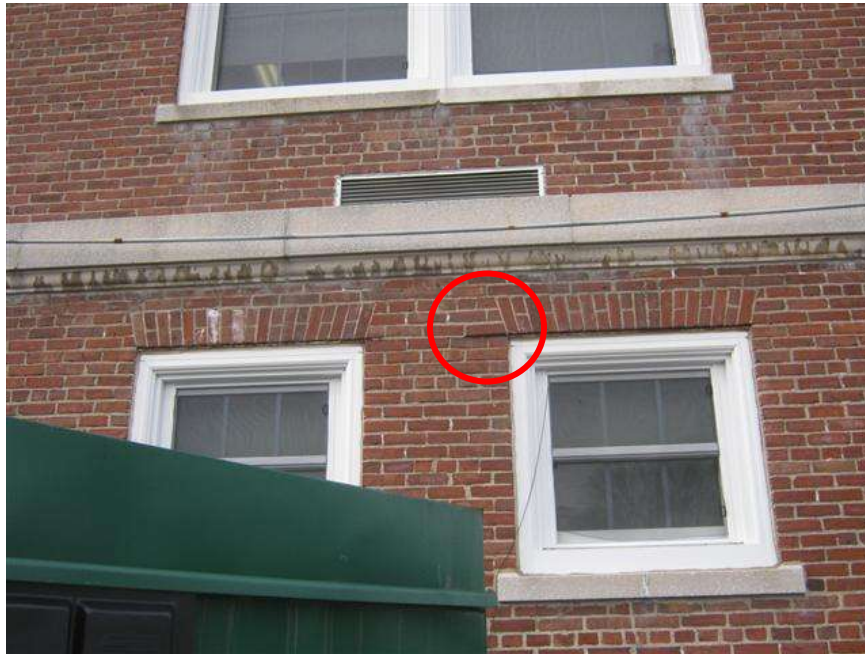
- The next concern also involves the exterior masonry walls at the steel lintels. Several of the lintels are exhibiting corrosion to the steel angles. The corrosion is forcing the exterior brick to move outward which allows more water to enter behind the lintel. Corrosion will accelerate as the mortar and brick open joints through the movement of the brick. Weep holes and flashing are not visible from the exterior of the building. The flashing would protect the steel angles and provide end dams to keep any water entering the wall above the windows from draining into the brick beyond. The weep holes would be located directly on top of the flashing and provide drainage of the water to the exterior.

Spalled mortar at lintel bearing condition

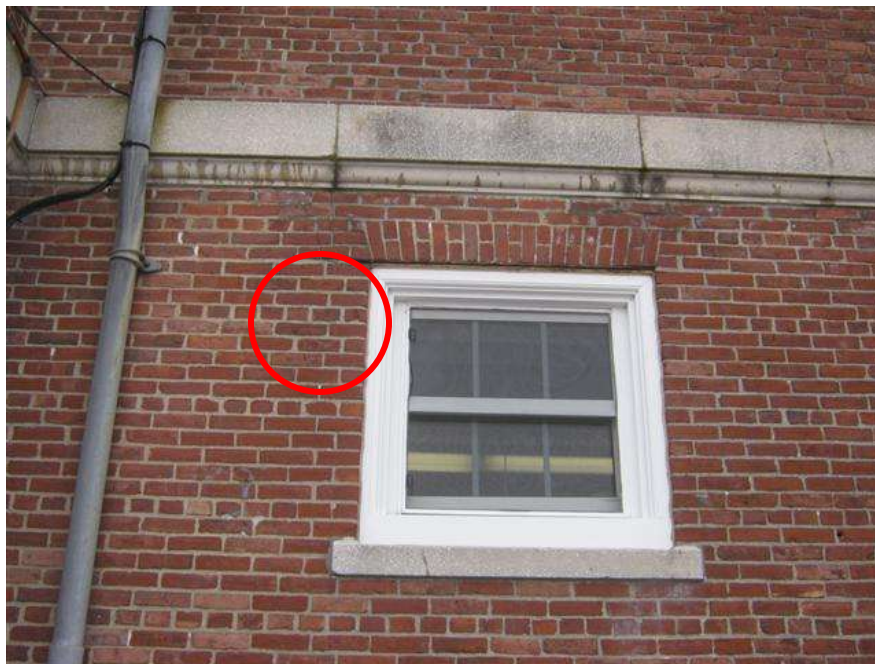
Spalled mortar joint at steel lintel

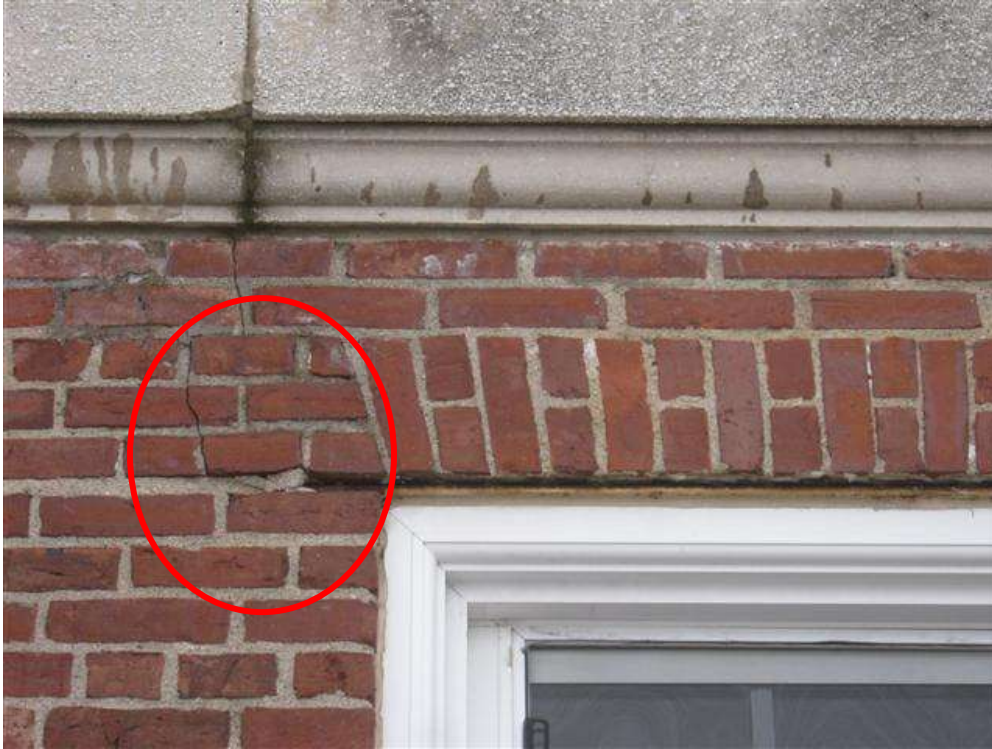
Close up of spalling and cracking brick indicating movement in the lintel due to corrosion

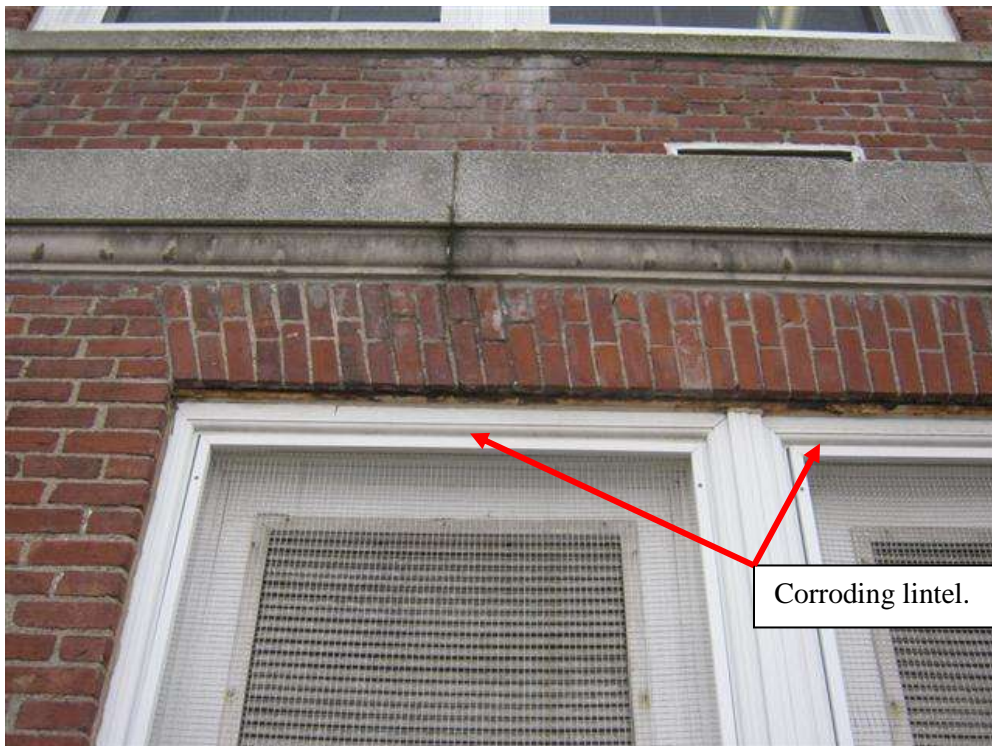
Visible lintel corrosion

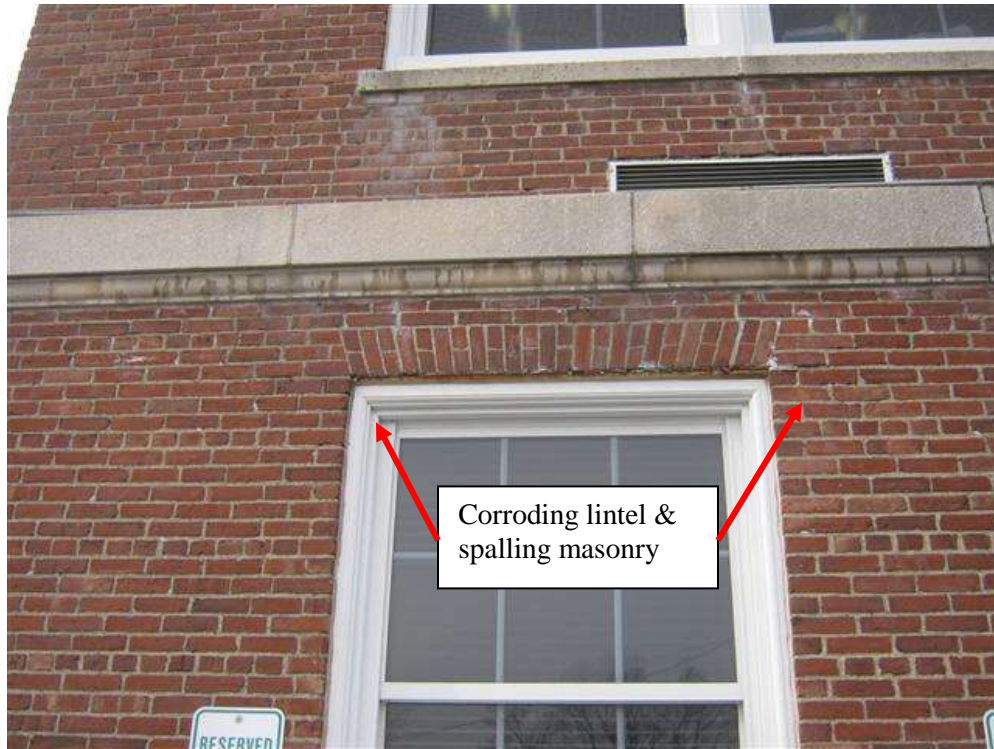
Corrosion damage to lintel and movement in exterior brick due to corrosion

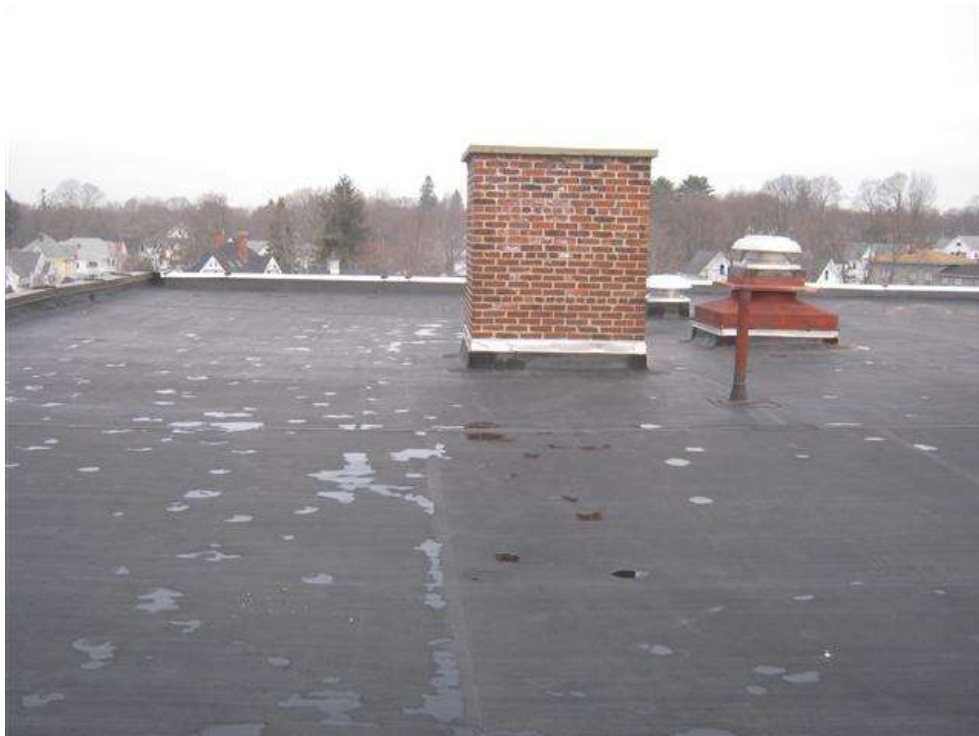
- The masonry chimney projecting above the roof line requires repairs. Vertical and horizontal cracks and spalling have developed in the brick and mortar. The movement and cracking has allowed additional water to enter into the wall. As the brick and mortar absorb the water, the damage will increase.

Spalling and cracking in chimney brick and cap looking north

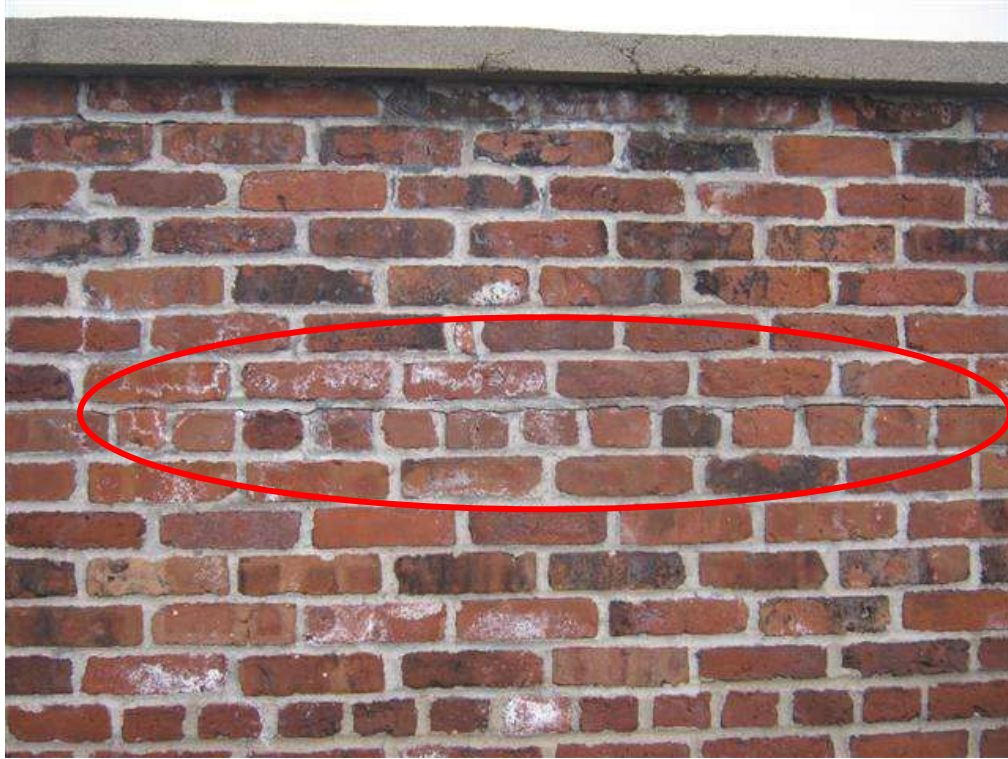
Close up of cracks and spalling

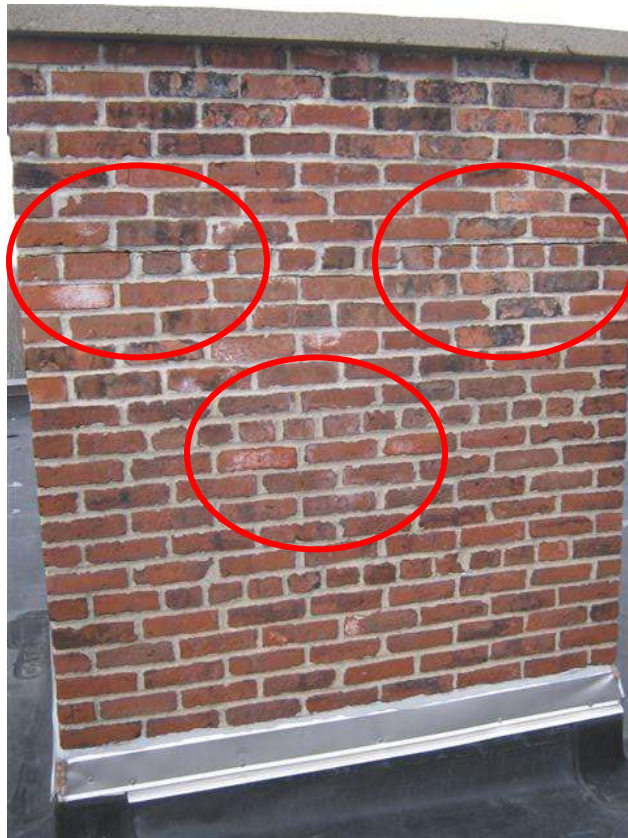
The east face of chimney with spalling brick face

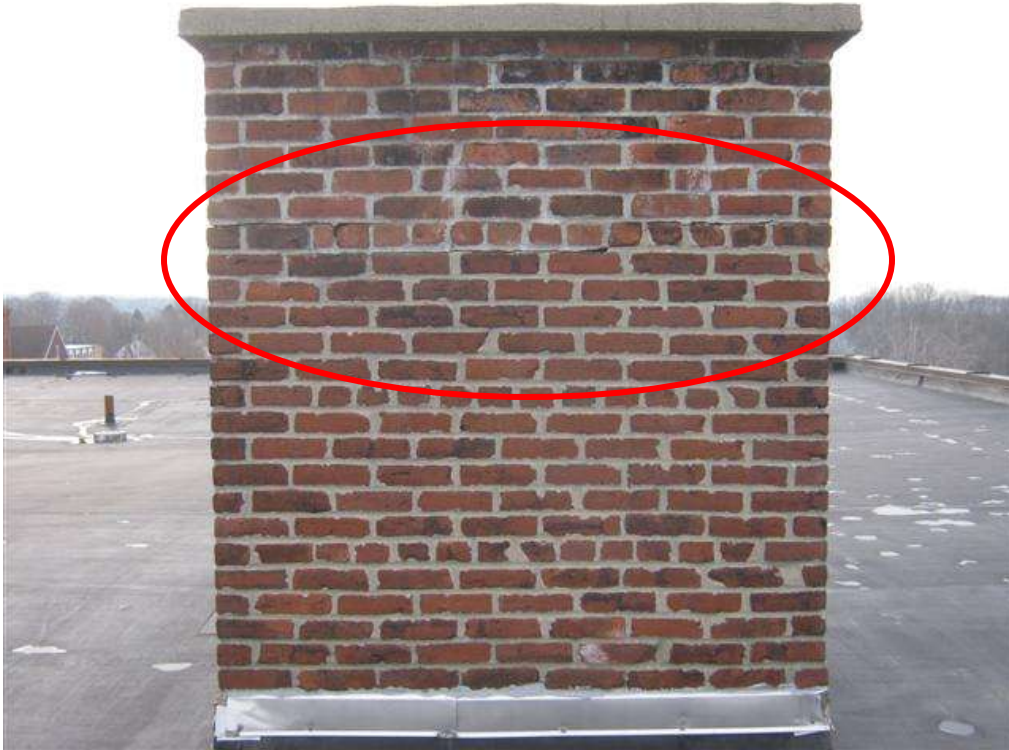
Cracks, spalling and movement in brick on west face

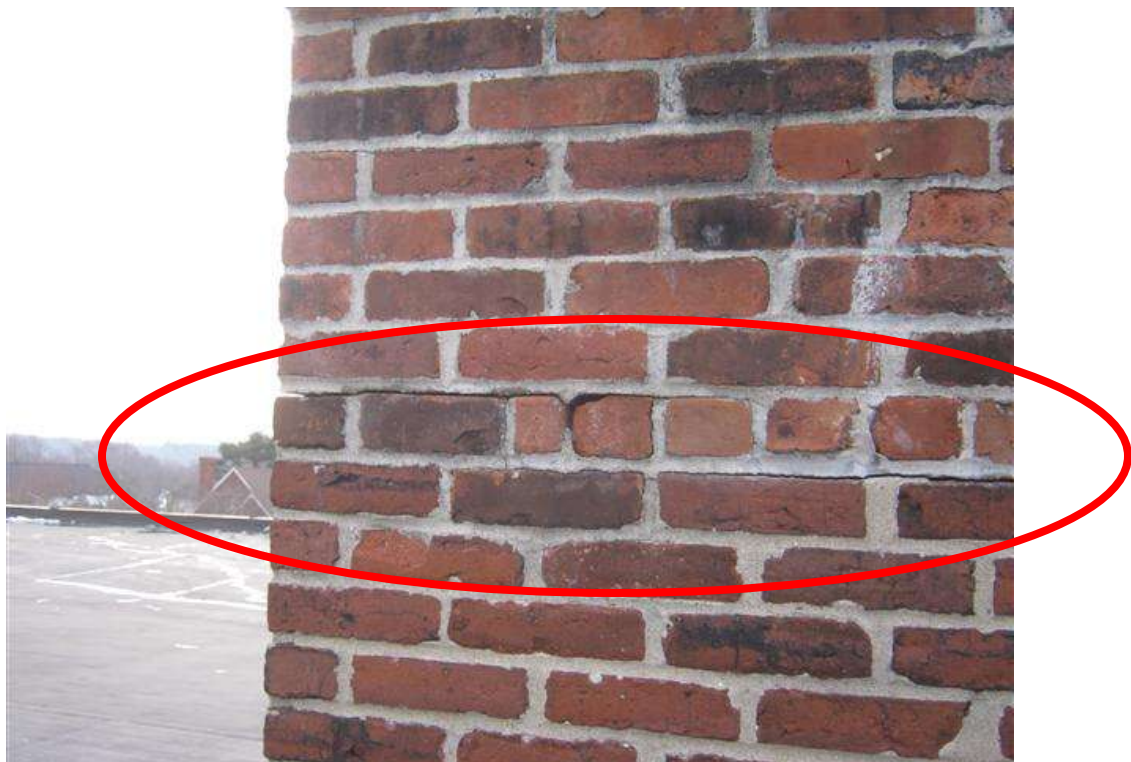
Close up of cracks, spalling and movent

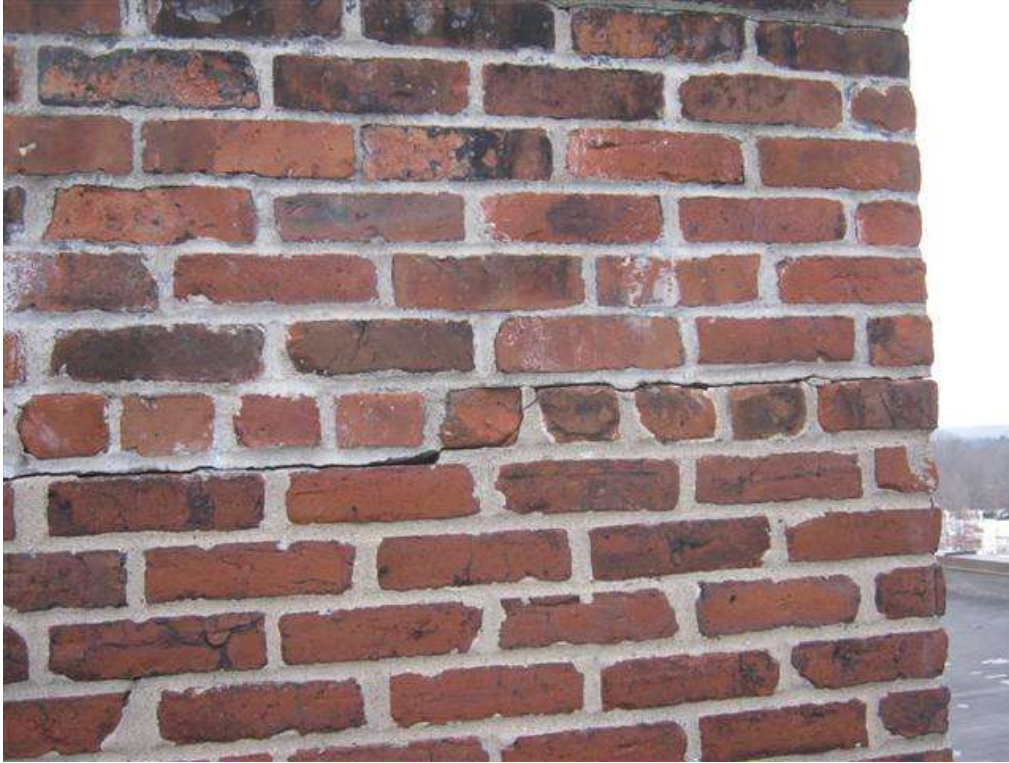
Movement and cracking in chimney

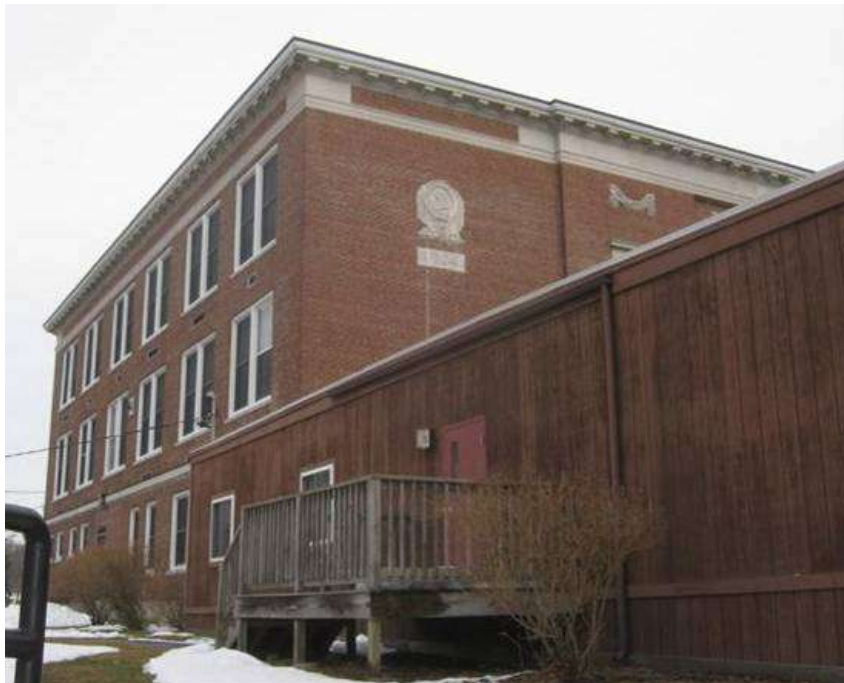
- The exterior wood sheathed portable classrooms are showing signs of severe rotting and possible mold growth on the exposed face of the sheathing. A portion of the condition is caused by missing downspouts and damaged gutters that allow water to be able to splash against the walls and soak the porous sheathing. In areas where the sheathing deterioration is excessive, possible rotting to the wall framing may be occurring.

Portable classrooms with deteriorating sheathing along the west face

- The damaged sheathing on the modular classrooms must be replaced to avoid further damage to the framing. The void between the portable classrooms and the original construction should be sealed with a vertical expansion joint cover. The missing downspout should be replaced and the leak in the gutter on the south elevation should be investigated and repaired. At the time that the sheathing is removed, an Engineer from Kaestle Boos Associates should be present to inspect the wall framing for deterioration.

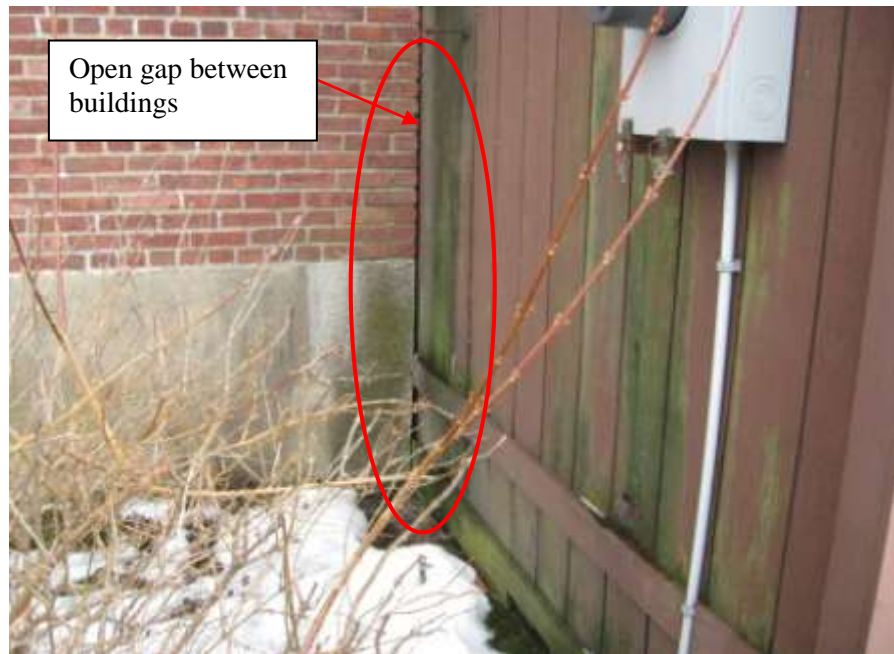
A sizable gap was observed between the original construction and the portable at the south west corner of the facility where wind driven rain enters the void between the structures creating a favorable environment for mold and mildew.

Sheathing turning green due to constant wetting

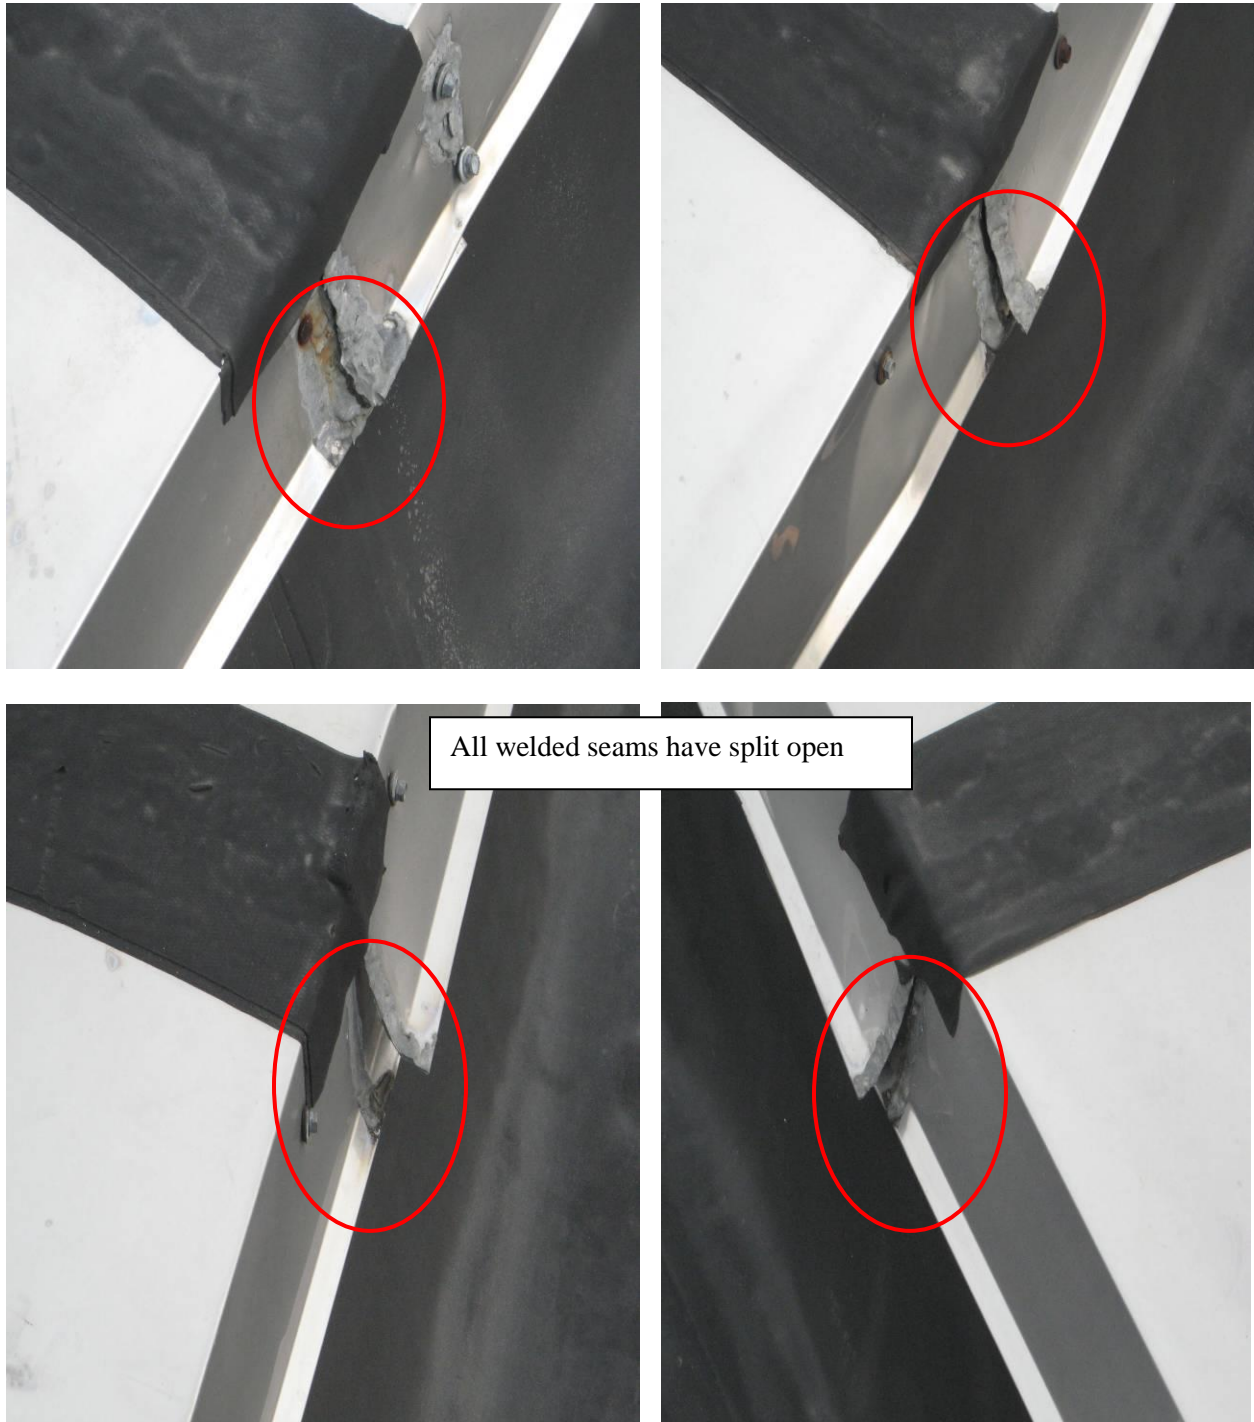
The open seams at the joints between sections of coping were patched with peel and stick flashing tape however several taped seams are splitting open. If the roof membrane was not extended under the copings to seal the masonry at the top of the parapets water infiltration into the wall assembly is most likely occurring.

- The existing EPDM roof is in good condition and should provide adequate waterproof protection for another 5 to 7 years. However, the stainless steel copings should be removed and replaced with copper or copper colored aluminum sheet metal with properly sealed seams. In the process of removing and replacing the stainless steel copings attention should be given to inspect the EPDM membrane to make sure that it extends over the top of the parapets to completely seal and protect the masonry walls.
- The two circular windows should be removed and new aluminum framed double pane windows be installed. If that is not possible at this time, a circular Plexiglas window should be placed over the exterior face of the original wood windows to provide protection from the elements and prevent further damage.

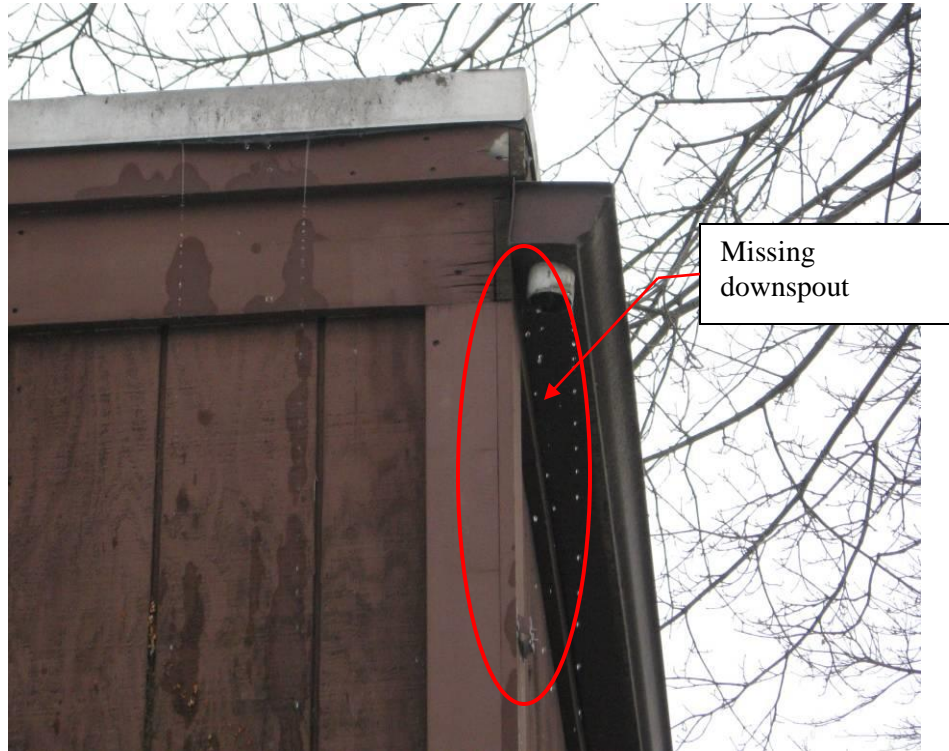
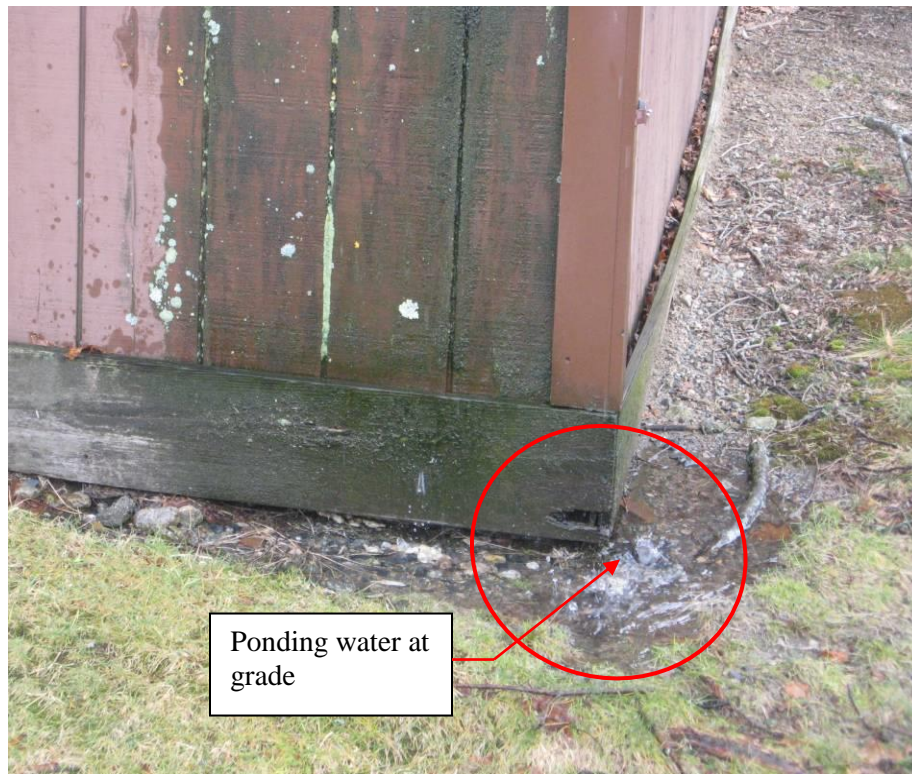
The gutter on the south elevation is leaking. Water dripping down the face of the wood veneer is getting water damage and mold.

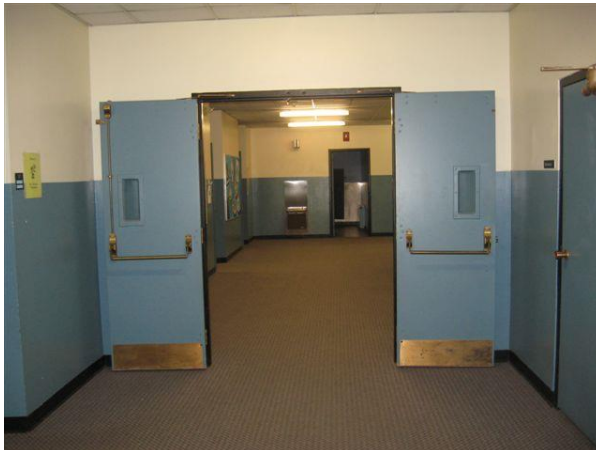
Doors pairs at stairwells, in corridors, and at the Media Center are not wide enough to comply with egress requirements of the Code. Throughout the building, doors do not provide required clearances, hardware, and width for handicapped accessibility. Old style crashbars are still in place on egress doors and are not compliant with current Code.

- Door pairs at stairs and common rooms should be replaced with compliant doors of required width, rating and hardware.
- Doors to classrooms should be demolished and replaced with new doors on the corridor face or be replaced with new doors swinging into the classroom to provide accessible clearances and hardware. Where this cannot be provided, automatic door operators should be installed. This is not recommended, however, as this requires the doors to be provided with a door closer and may be difficult for young children to operate.
- All other doors serving common areas and storage rooms should be replaced with new doors and hardware to provide accessible entrances.
