**Re: Davis- Thayer Existing Conditions Report – March 21, 2023**

# DAVIS THAYER ELEMENTARY SCHOOL

## EXISTING CONDITIONS REPORT

March 21, 2023

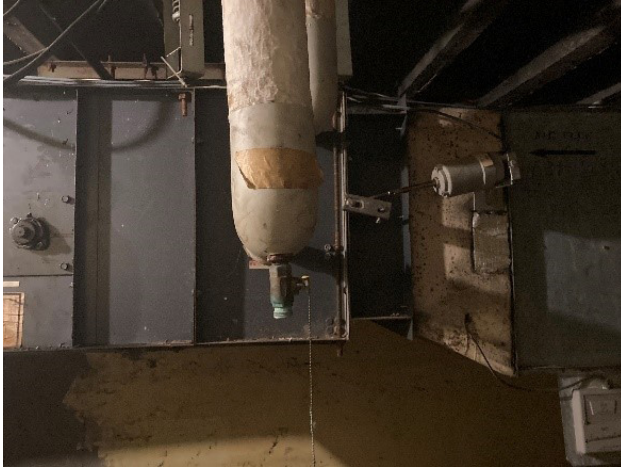
AHU-1 in basement, note pneumatic actuator

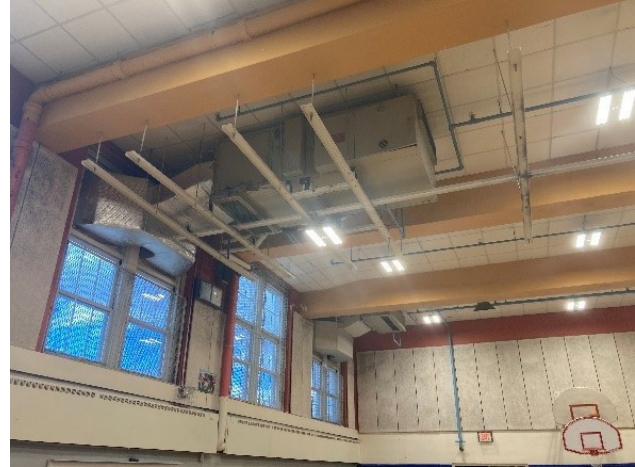
AHU-2 at gym ceiling & horiz. UV beyond

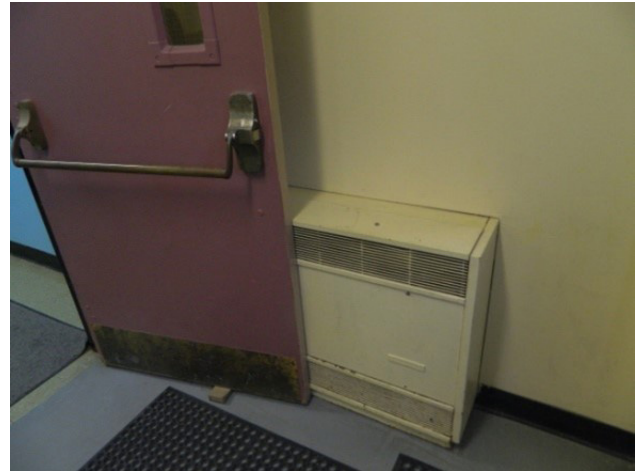
Typical Cabinet Unit Heater

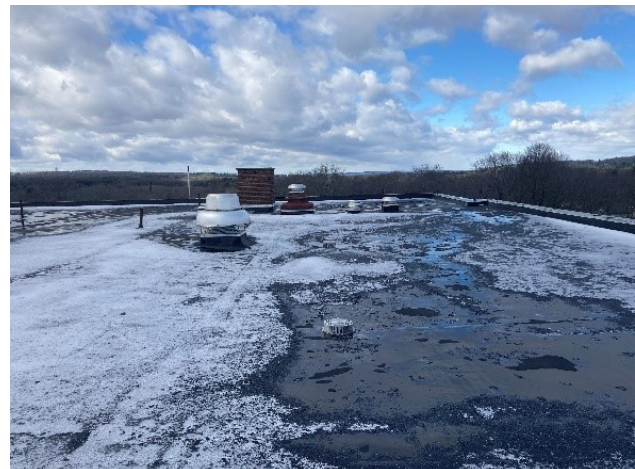
Roof, note exhaust fans
