STUDY FOR THE

DAVIS THAYER ELEMENTARY SCHOOL

FRANKLIN, MASSACHUSETTS
MAY 31, 2013

KAESTLE BOOS
associates, inc

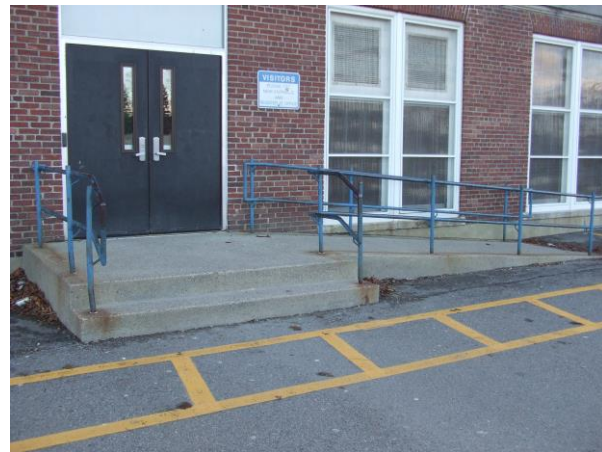
Northeast entrance and ramp

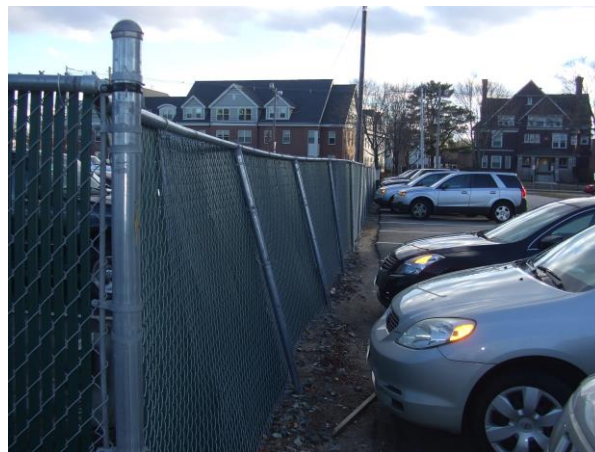
Fence bent out of place/ Dean College property line

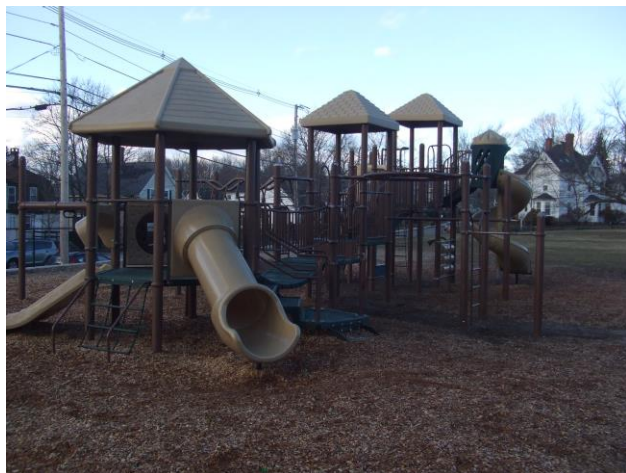
1. The structure does generally meet ADA.
2. Some parts show rust and need to be sanded, primed and painted.
3. There is a missing wheel on the pipe barrier.
4. The picnic table and benches have been vandalized and should be replaced.
5. Due to drainage patterns passing directly through the play structure, much of the wood mulch is being washed toward the retaining wall on Union Street. Drainage should be installed to prevent this in the future.

Miracle Recreation Play structure

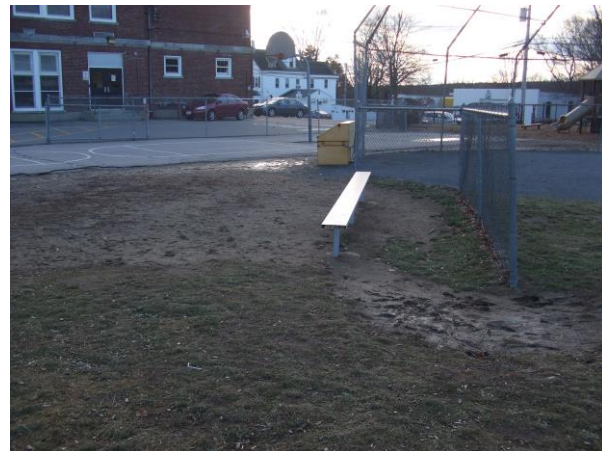
Drainage problems are mostly related to the playground where inadequate drainage in the stone dust infield and by the swings causes ponding and subsequently mud when the areas are subject to heavy foot traffic. Most of this water is due to sheet flow directly from the driveway /stacking area. A major drainage swale runs under the playscape, as mentioned previously, which drains to the rear of the retaining wall at Union Avenue. Not only is this swale removing large amounts of wood chips that are necessary for fall safety at the playground, it is also eroding the rear of the wall, exposing the rear façade and possibly subjecting it to failure in the future. There is a small erosion problem by the northwest corner of the Dean College parking lot, but this may be caused by overuse from students. This erosion has exposed chain link fence posts as well as the end of the retaining wall supporting the upper platform currently not used by the school. The majority of the south side of the school simply drains onto Rte. 140. No drainage system was observed on site, other than the drainage for the accessway to the basement on the west side of the school.

Low area retaining water, turning to mud

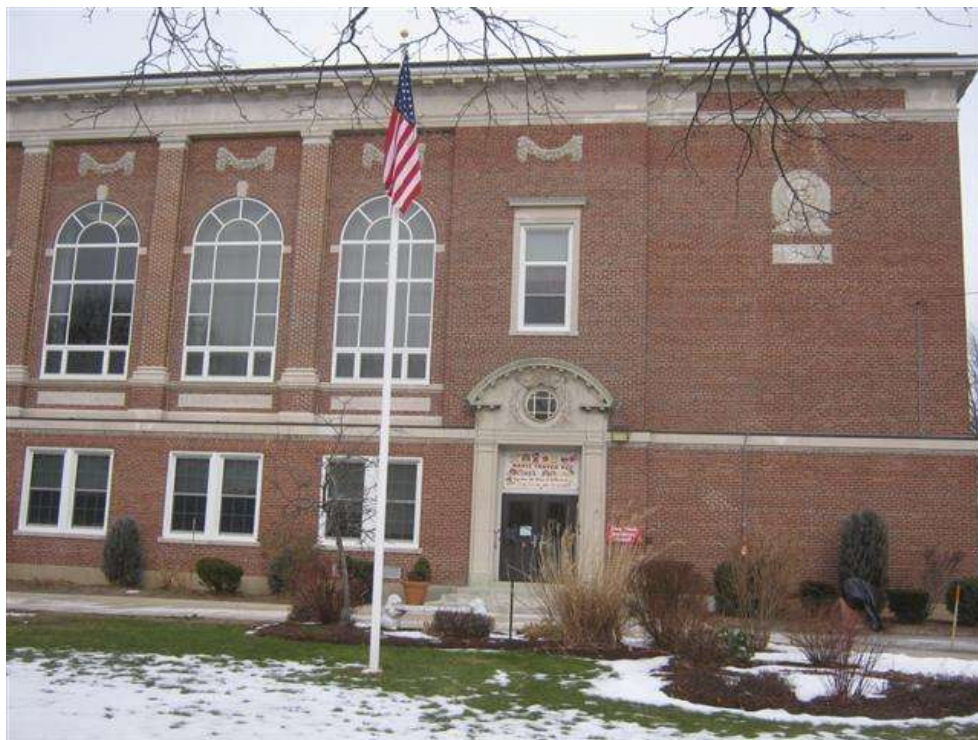
South face of School

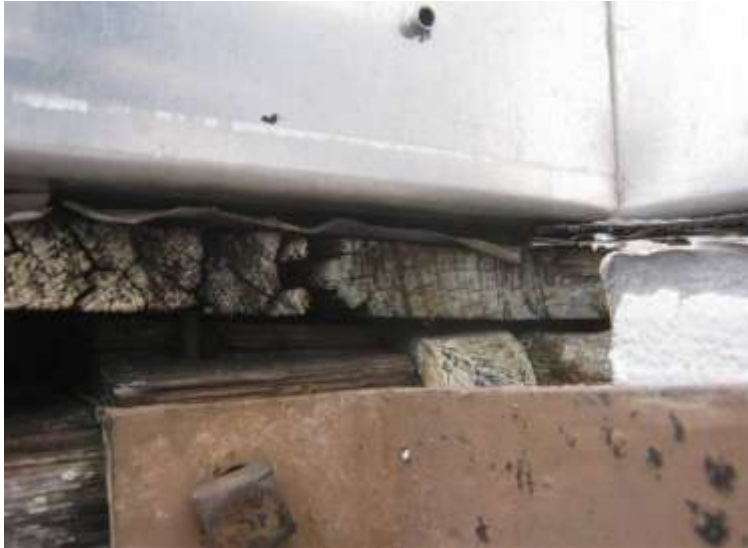
Tongue and groove wood roof deck at hatch

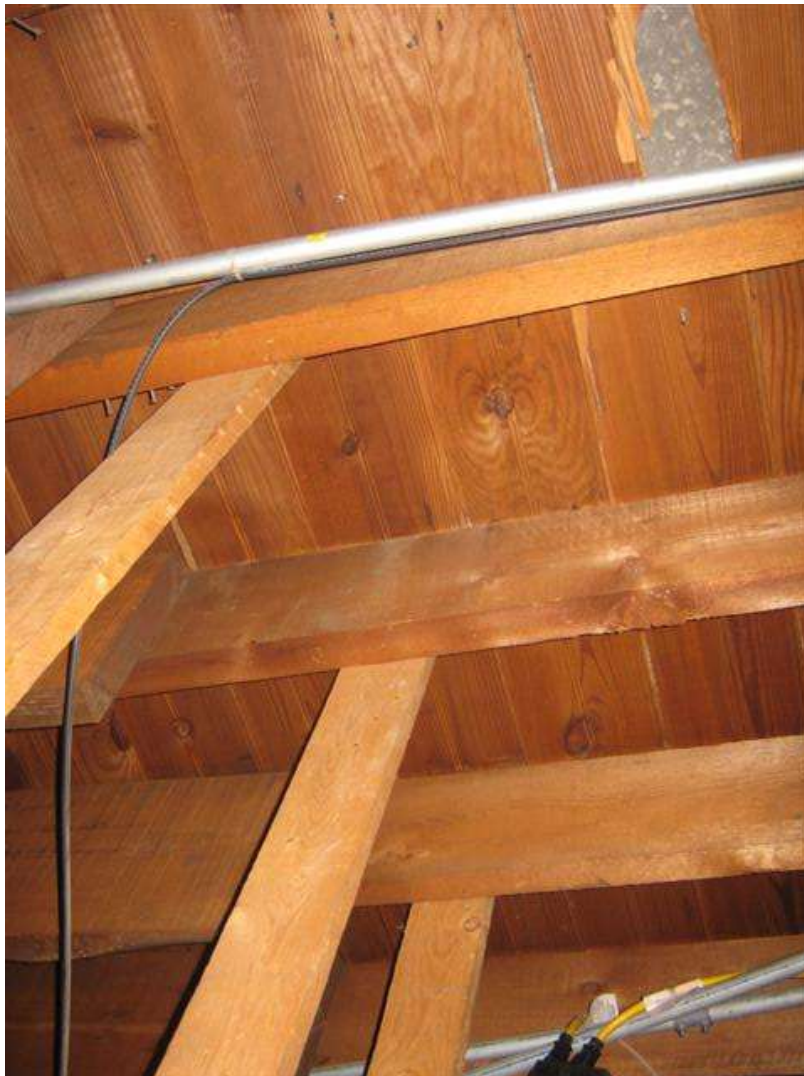
Wood roof joists and deck and supporting bearing walls

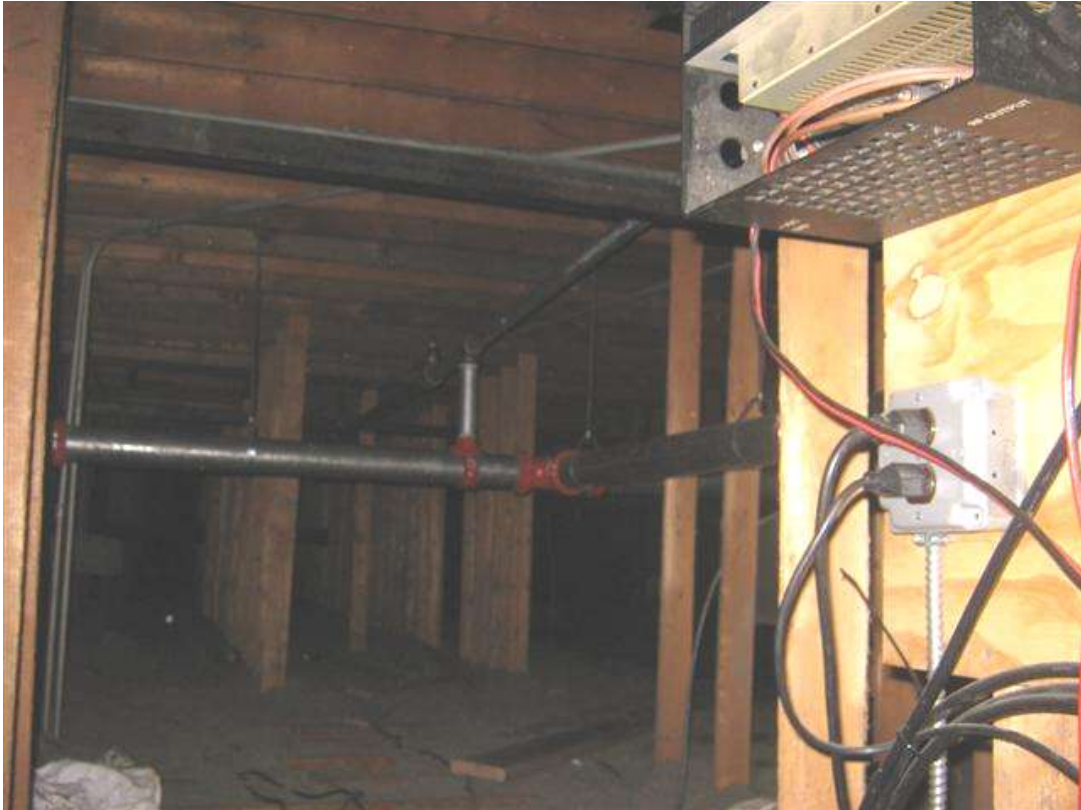
Bearing stud walls throughout the attic space

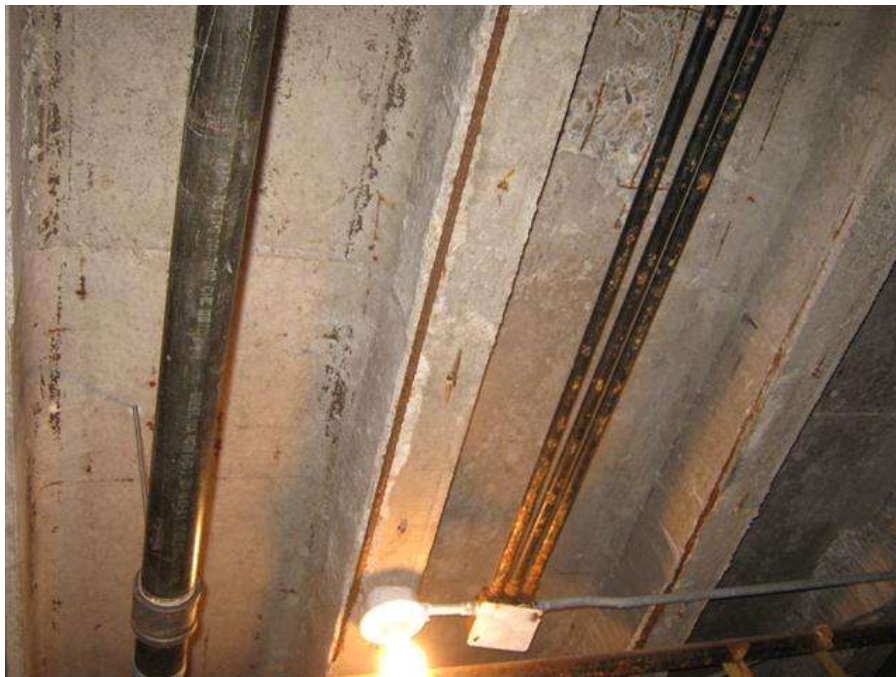
Cast in place concrete tee floor slab

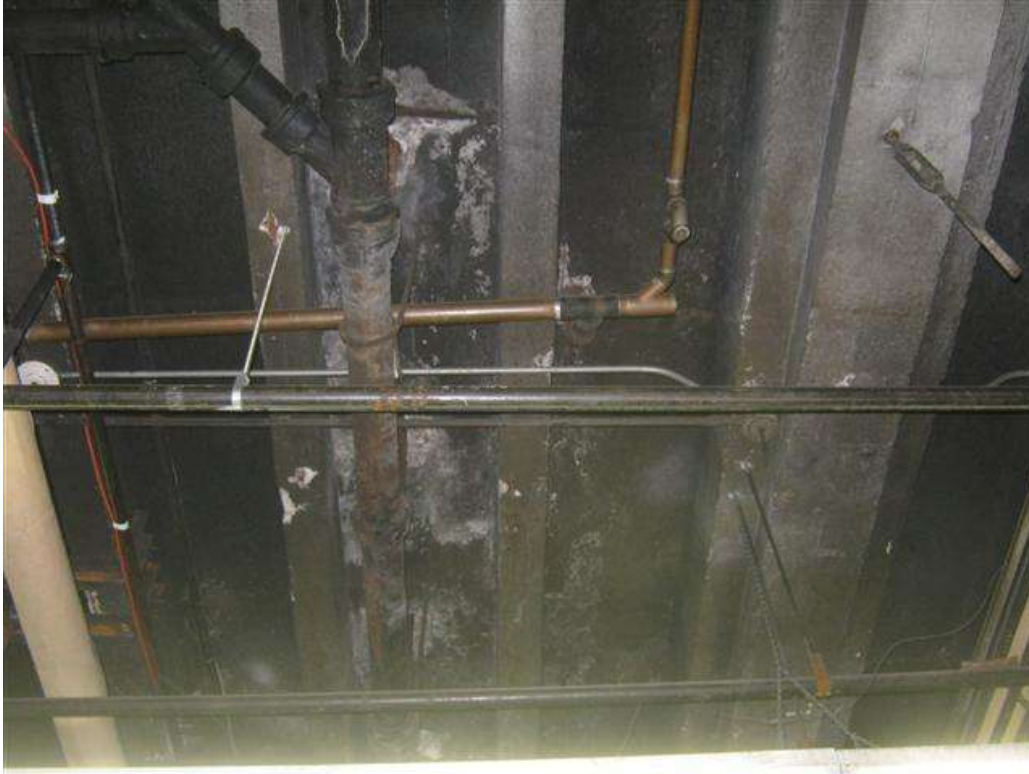
Cast in place concrete tee floor slab viewed from the Boiler Room

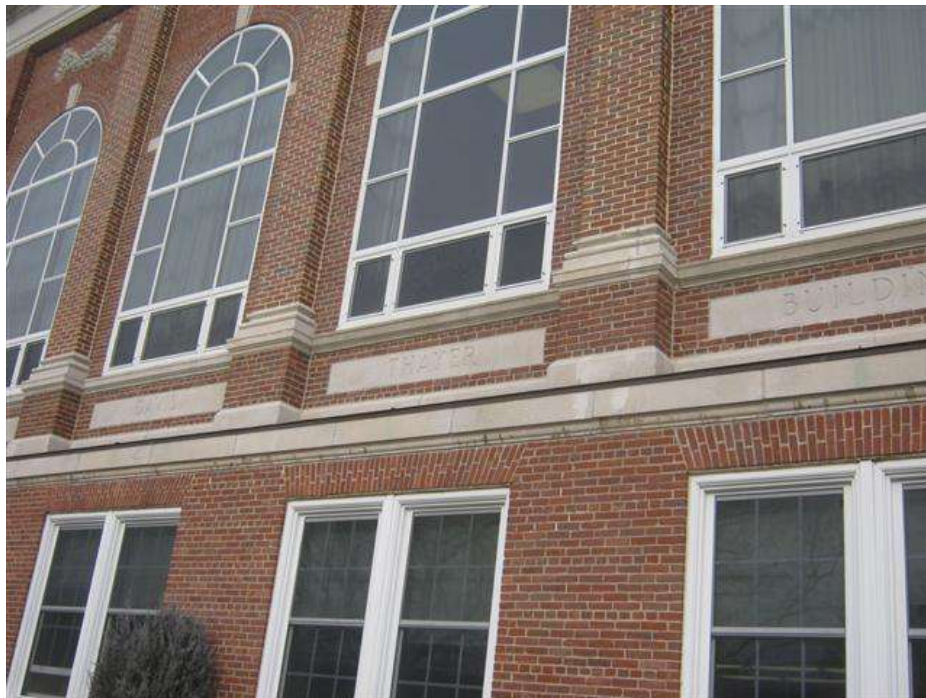
Exterior brick wythe viewed along south wall

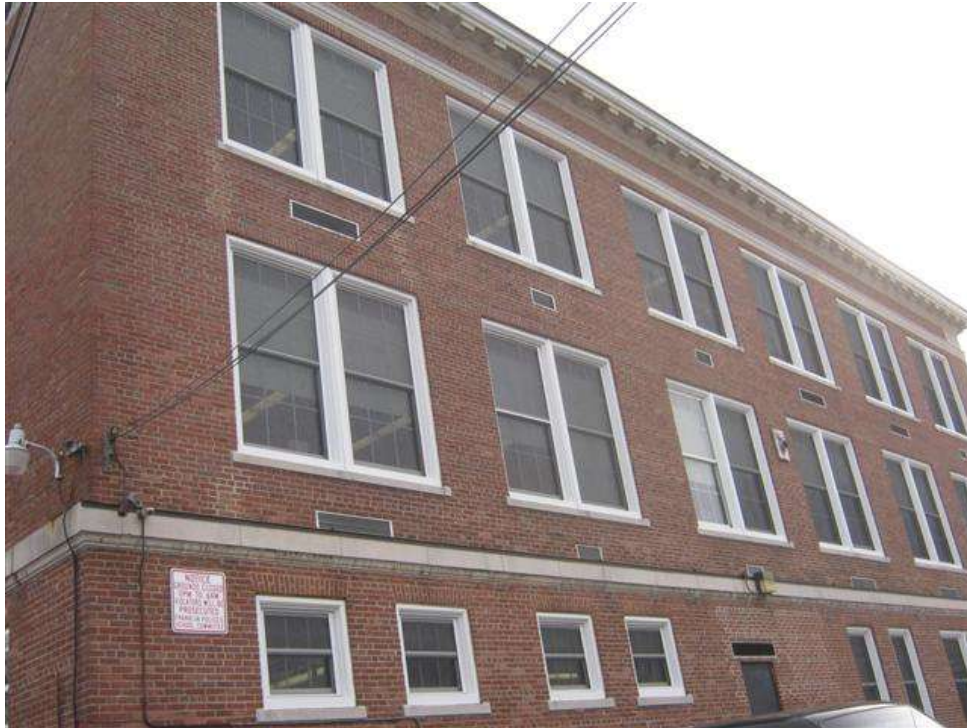
Exterior masonry bearing walls looking at east face

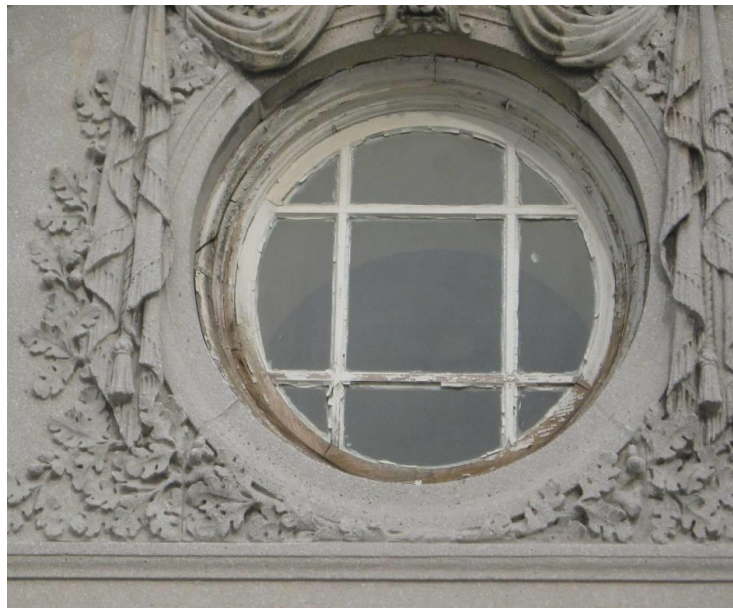
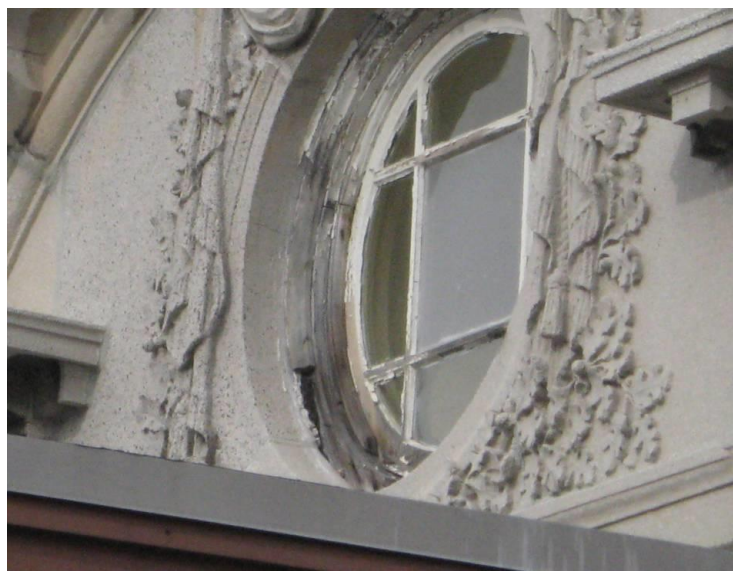
The windows are a residential/light commercial type aluminum replacement window with the original wood frames left in place. These were replaced recently and appear to be in excellent condition. However, the two original circular windows in the stairwells above the entrances have not been replaced or protected and consequently the wood has deteriorated to a point where wind driven rain infiltrates through the window. Exit doors at the main entrances are in good condition with new exit devices.

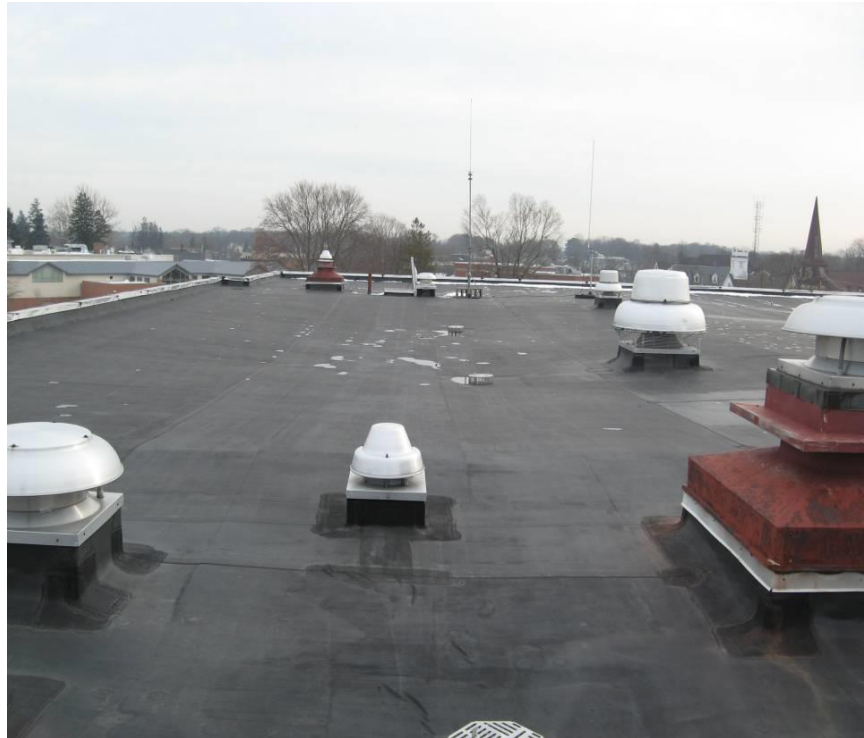
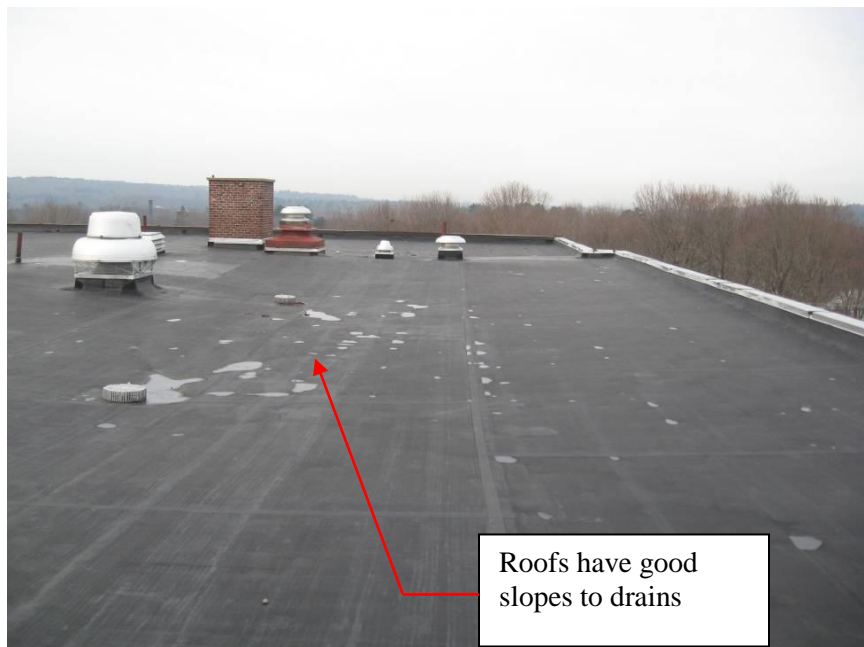
The Davis Thayer School roof was built in 1924; the current roof consists of a fully adhered EPDM membrane on a wood deck. The EPDM membrane appears to be less than 10 years old and is in good shape with no reported leaks. The slopes to the drains are greater than 1/4" per foot and no ponding water was observed.

No open or damaged lap seams were observed.

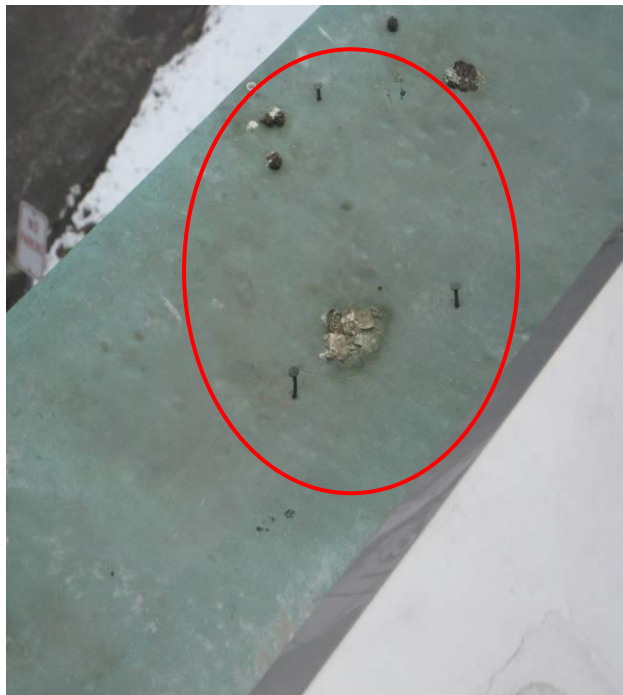
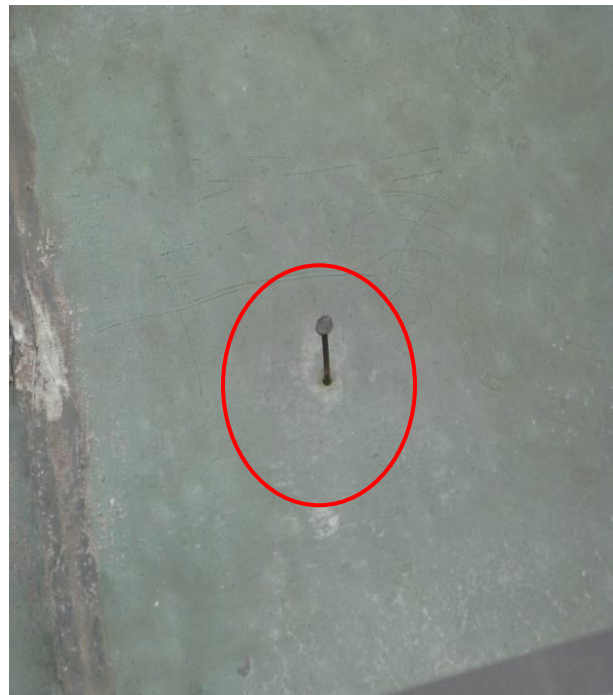
Nails were driven through the top of the original copper parapet flashing. The nails are backing out and can allow water to infiltrate into the wall system.

- The existing EPDM roof is in good condition and should provide adequate waterproof protection for another 5 to 7 years. However, the stainless steel copings should be removed and replaced with copper or copper colored aluminum sheet metal with properly sealed seams. In the process of removing and replacing the stainless steel copings attention should be given to inspect the EPDM membrane to make sure that it extends over the top of the parapets to completely seal and protect the masonry walls.
- The two circular windows should be removed and new aluminum framed double pane windows be installed. If that is not possible at this time, a circular Plexiglas window should be placed over the exterior face of the original wood windows to provide protection from the elements and prevent further damage.

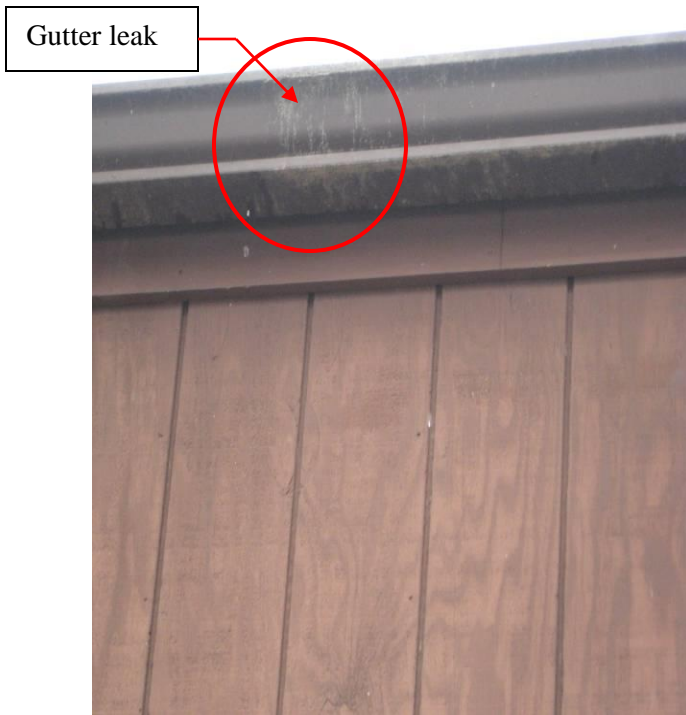
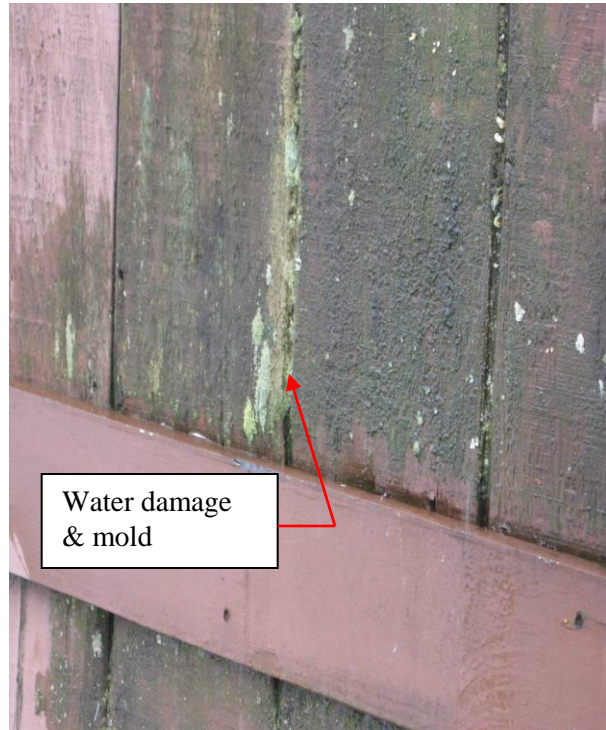
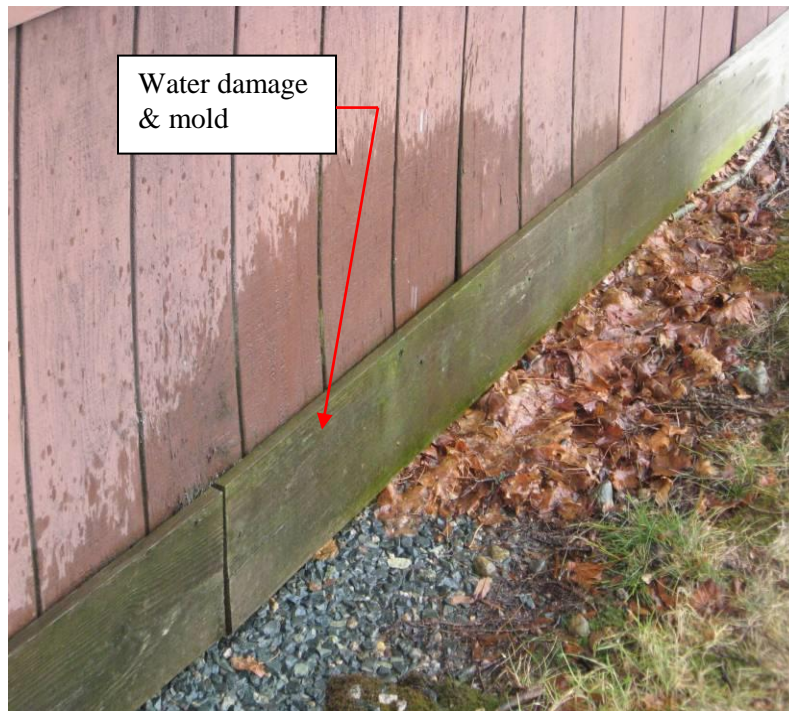
The gutter on the south elevation is leaking. Water dripping down the face of the wood veneer is getting water damage and mold.

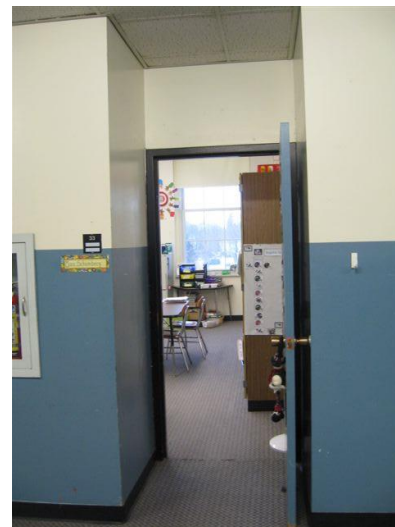
Interior doors are painted steel or stained wood in metal frames. A few doors have been installed with residential grade painted wood frames and casings. Most of the doors are presumed to have been part of the original construction and show wear, dents, and other damage. Classroom doors are set in deep recesses in the corridor walls. During the 1973 renovation, most of the classroom doors were moved from the corridor face to the classroom side of these recesses creating non-compliant and non-handicapped accessible entrances to these rooms.

Doors pairs at stairwells, in corridors, and at the Media Center are not wide enough to comply with egress requirements of the Code. Throughout the building, doors do not provide required clearances, hardware, and width for handicapped accessibility. Old style crashbars are still in place on egress doors and are not compliant with current Code.

- Door pairs at stairs and common rooms should be replaced with compliant doors of required width, rating and hardware.
- Doors to classrooms should be demolished and replaced with new doors on the corridor face or be replaced with new doors swinging into the classroom to provide accessible clearances and hardware. Where this cannot be provided, automatic door operators should be installed. This is not recommended, however, as this requires the doors to be provided with a door closer and may be difficult for young children to operate.
- All other doors serving common areas and storage rooms should be replaced with new doors and hardware to provide accessible entrances.

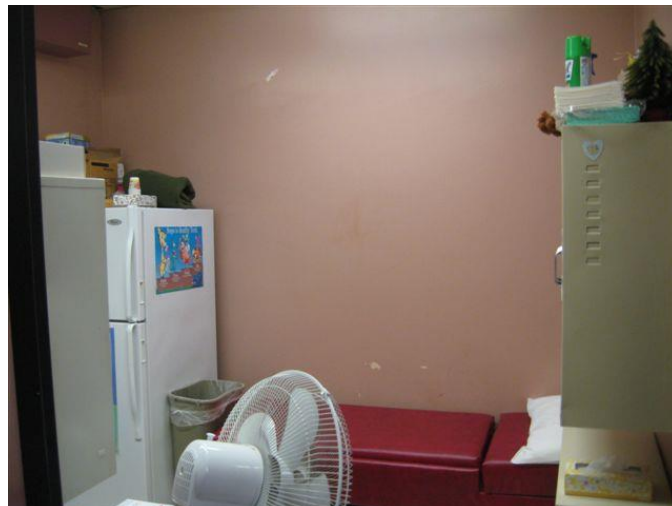
The Administration offices are undersized for the staff using the space. Controlled access is not provided through the Administration office as the main entrance door is remote from the administration location.

The Nurse's office is undersized and does not provide accessible entrances, cot space, or toilet rooms for patients.

The Administration offices should be enlarged and reconfigured to provide adequate space for staff, secure storage for private material, and controlled access to the school.

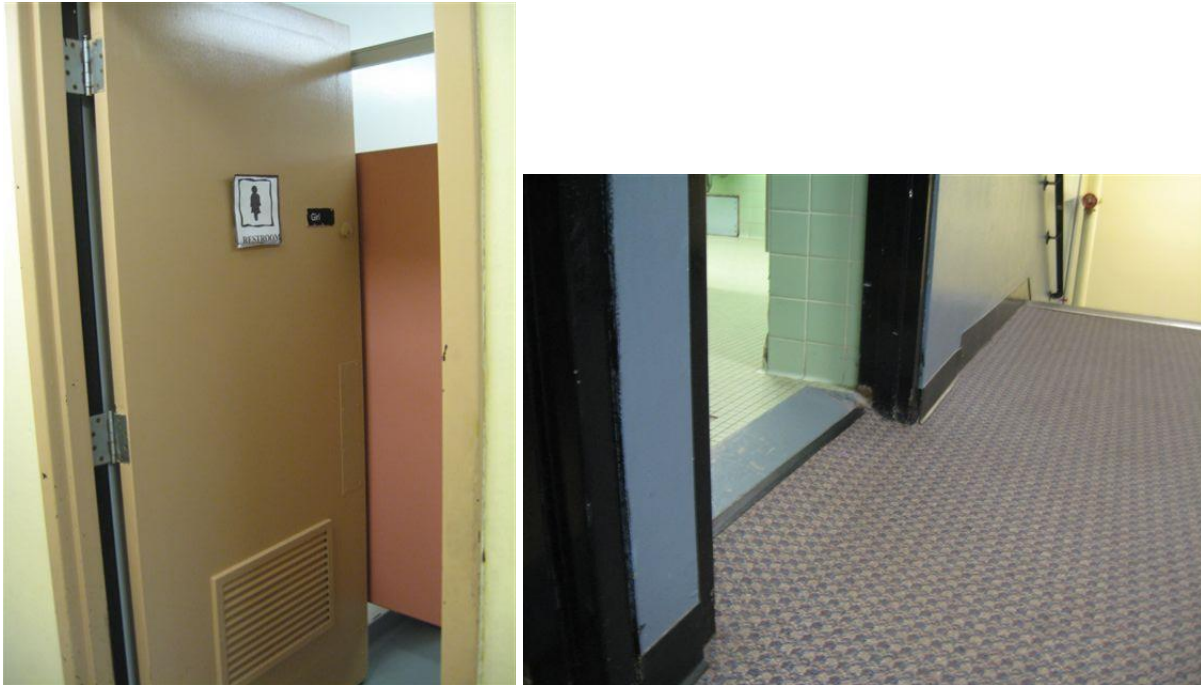
Custodial closets and storage spaces are provided in the original locker room spaces; in one space the original tiled shower space with shower fixtures remain in place with material stored in the shower. Custodial spaces are provided on each floor for equipment and supplies as no elevator exists to transport equipment.

- Toilet rooms should be reconstructed or relocated to provide compliant clearances and fixtures.
- Storage spaces should be provided within each re-sized classroom space for individual use. Common storage space can still be provide in corridors or common areas of the building.

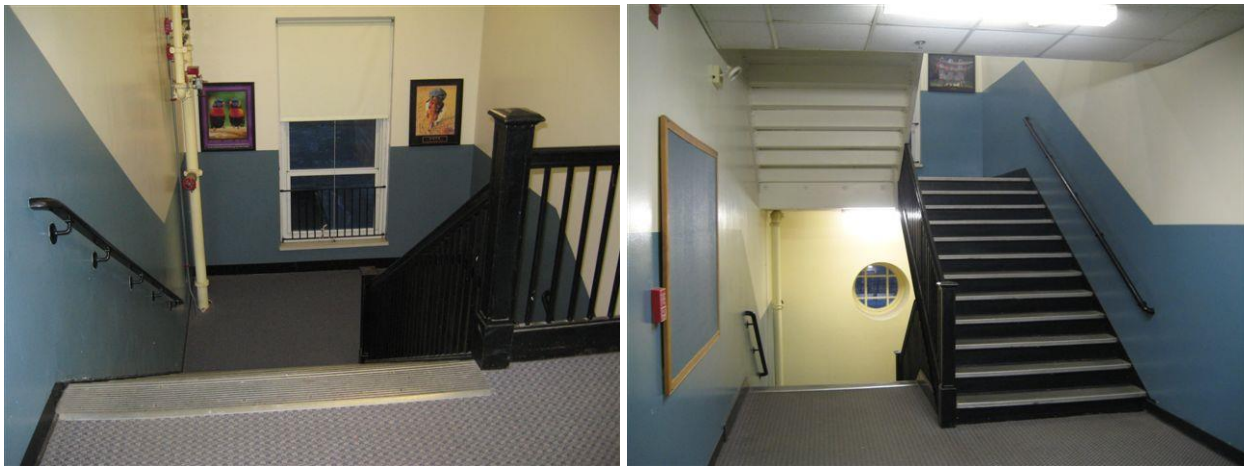
The building has 2 interior stairwells on the front of the school at each end of the main circulation corridor providing egress from the Second and Third Floors to grade. The Basement has 2 stairs providing egress from the Gym to grade at the rear of the school. Stairs are steel framed with concrete filled pans and terrazzo finish. The guardrails are not of compliant height and the interior stair railing is set between newel posts. Stair treads and risers are typically 7” high and 10” deep; these cannot be modified without rebuilding the entire stairwell.

No elevator is provided to access the Basement, Second, or Third floors.

- Rails on the inside of the stairwells should be modified to provide a 42” high guardrail and a continuous handrail for compliance with Code and accessibility guidelines. Handrails on the wall side of the stairwells should be replaced with a railing with a code compliant profile. This handrail should be mounted at the required height and have extensions at the top and bottom of each flight.
- An elevator should be provided for compliant access to all floors.

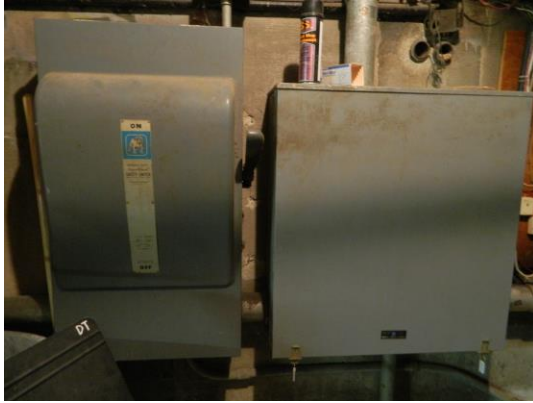
The building is served by a 400 Amp, 208V/120V, 3-phase, 4-wire Main Fused Switch located in the Electrical Room 147 in the basement. The switch and main distribution panel and much of the additional original electrical distribution equipment located throughout the building is manufactured by Westinghouse. The Main Panelboard appears to be in good working condition, but there is no evidence that circuit breakers are tested. Testing provides confidence that breakers will trip if required. The service is fed by an overhead service connection from a pole mounted transformer located on Union Street to a weatherhead service drop and conduit, exposed on the rear of the building, above the electric service.

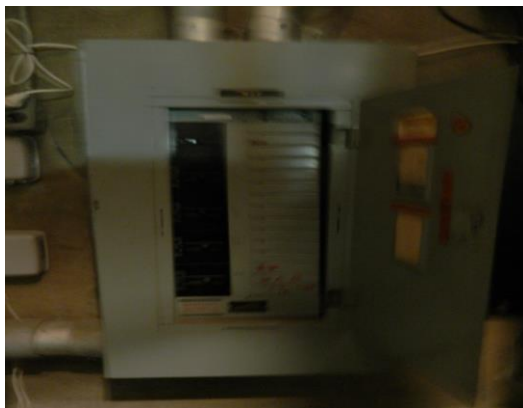
Lighting and power panelboards are installed at various locations throughout the facility. Most of those were manufactured by Westinghouse and appear to be in fair to good condition. Locating a source for replacement breakers for these panelboards is difficult and in most cases not available, so replacement of these distribution panels are recommended. There are two Motor Control Centers that were installed as part of the original renovation project, and they serve the HVAC equipment. MCC #1 is located in the basement Mechanical Room. MCC #2 is located in the Janitors/Elec. Closet 316 on the third floor. Both appear to be in fair to good condition. Replacement parts are difficult to find. Replacement of the MCC depends on the extent of proposed HVAC system modifications.

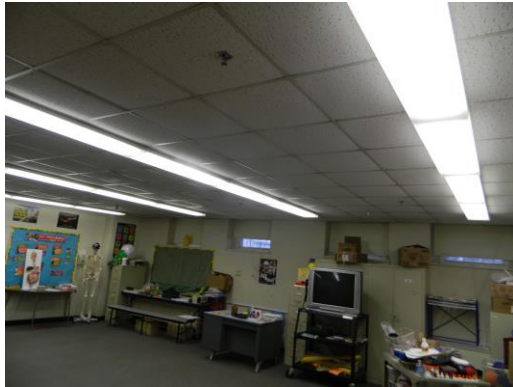
Much of the fluorescent lighting is old and installed during the major remodel of ceiling and lighting replacement in 1972. Lenses have typically yellowed throughout. Replacement of the existing lighting is recommended, and fluorescent lighting ballasts installed before 1979 may contain PCB's. No lighting control system was found. A lighting control system for the entire building is recommended for compliance with current energy codes.

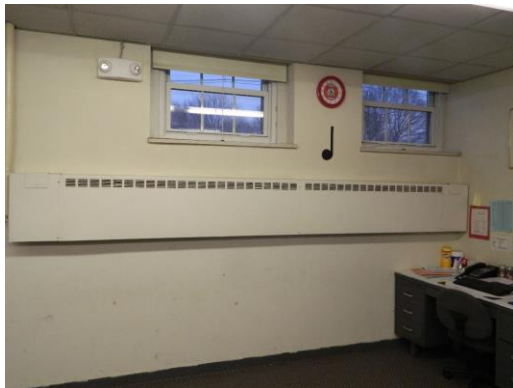
Emergency lighting is provided throughout the facility by battery type wall mounted units. Emergency lighting is considered to be minimal for a facility of this type. Existing units range from fair to good condition.

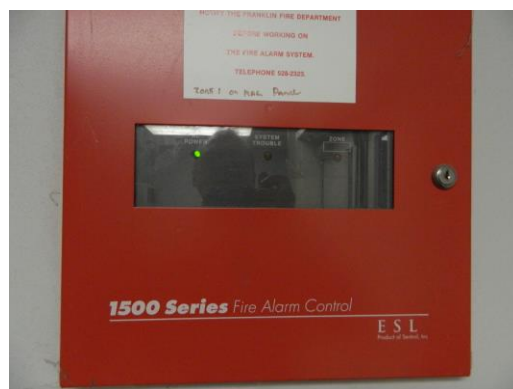
The Fire Alarm system serving the school was installed during an upgrade project and appears to be in good condition. The Fire Alarm Control Panel (FACP) is located in the in the basement. Re-use of the existing system may be possible. Further investigation is required to determine if parts are still available and whether the system meets present code requirements. A separate new fire alarm system was added for the portable classroom structures with complete alarm and notification devices. The system is provided, as no fire protection systems exist in the portable structures.

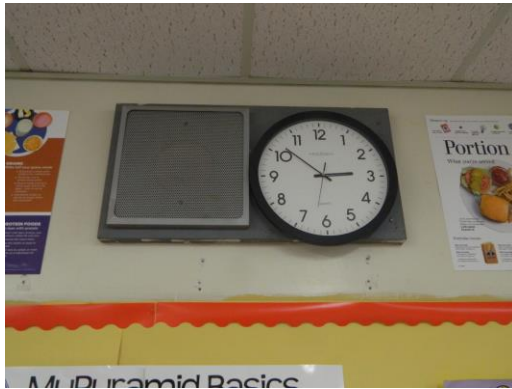
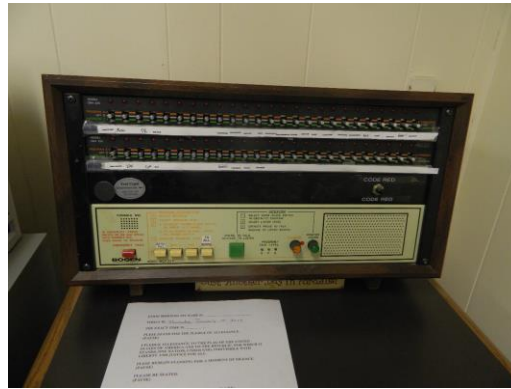
The existing PA system was provided as part of a building upgrade prior to the 1972 project. Many of the clock/speaker assemblies are not operational and have been modified with independent speakers and wall clocks. A new system is recommended.

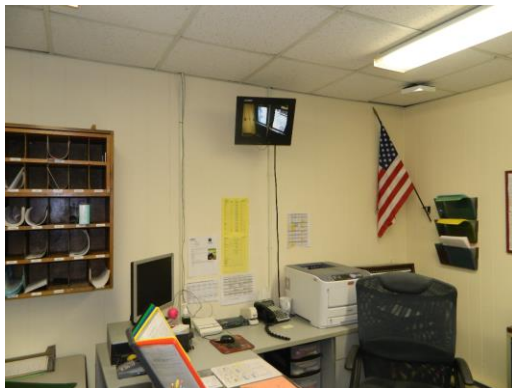
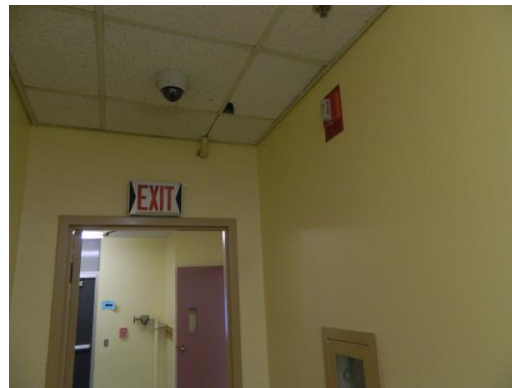
Security

The security system consists of an exterior mounted security camera and screen monitor in the main office. Details and condition of the security system(s) are unknown. A new system is recommended.

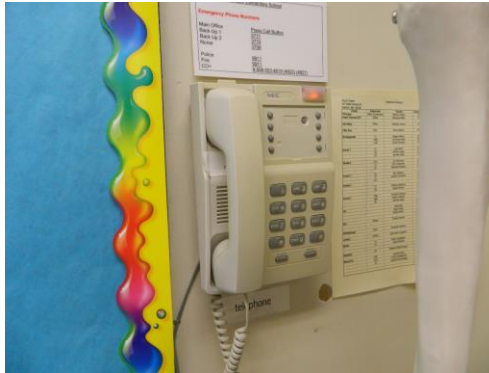
Telephone service appears to enter the building overhead from a pole located on Union Street. An NEC 8400 Series phone system was installed in 2011. This system should be upgraded to IP and new handsets provided for all classrooms and administration offices.

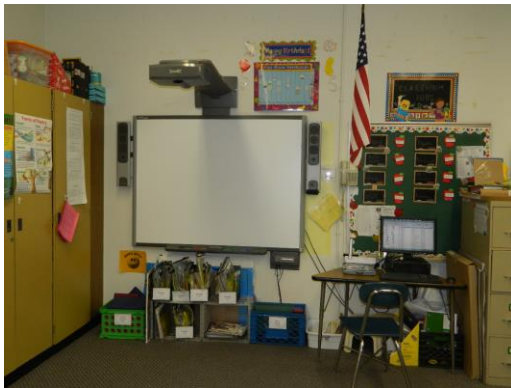
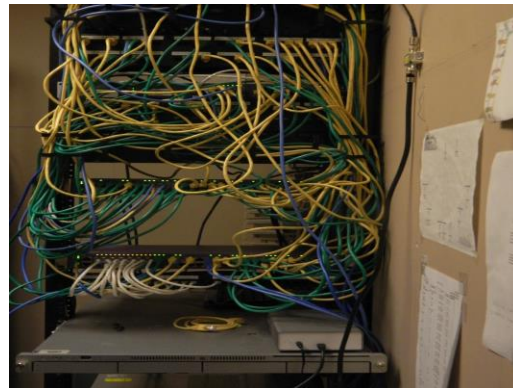
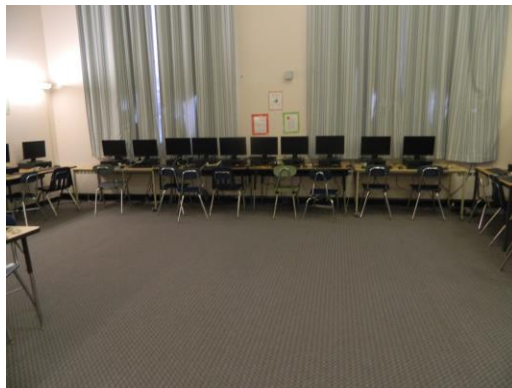
Data/Information

Data appears to be mostly a hard wired network with limited wireless devices. The power for the media center equipment is fed through numerous power strips and extended cords draped over the floor below the tables. Some of the classrooms serving the upper grade levels have been fitted with smart board technology for internet access.

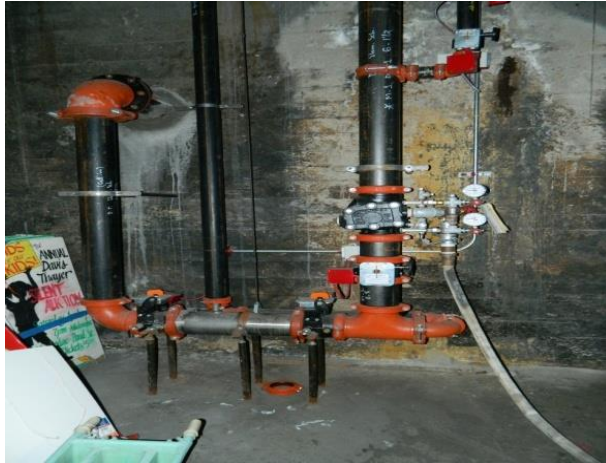
Fire Service System

Located within the basement general storage room 143 is a single 8" fire protection service entrance. The fire protection service enters the room through the foundation wall and transitions through an 8" elbow with a 6" reducing flange, drops and horizontally offsets above the floor to a floor mounted double check valve assembly and main system riser alarm valve. The system serves the school's combined standpipe riser, standpipe riser, wet fire protection system and remote located dry alarm riser located on the third floor. The dry alarm system riser assembly is located in the Teacher

Toilet Room 321. The dry system feeds the attic dry sprinkler system. The existing old fire protection service located off of the existing domestic water service located in Water/Electric Room 147 at the basement, is still connected with a double check valve assembly. The system is currently valved off. The new system was installed in 2007 and appears to be in good working condition.

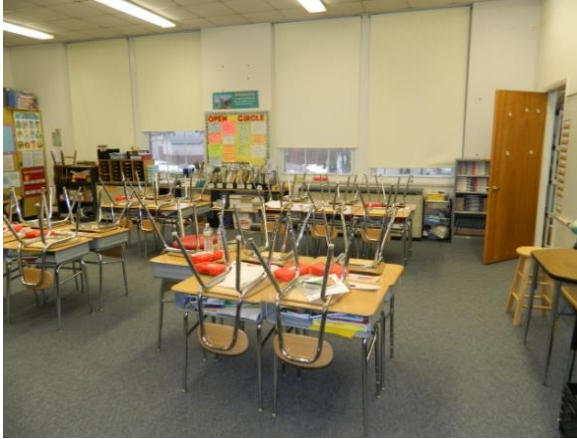
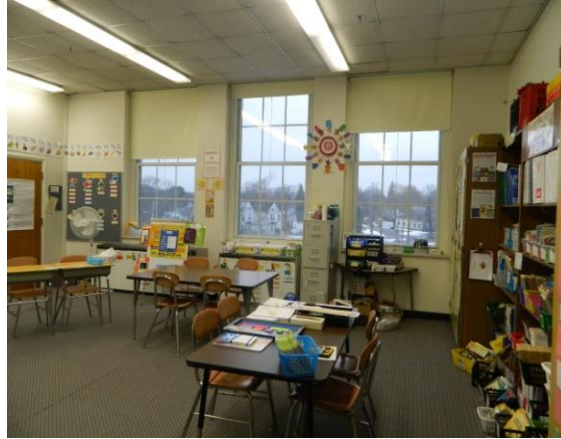
Classrooms, Corridors and Support Spaces

A full coverage wet sprinkler system is installed that covers the three floors of the building. Recessed pendant heads are installed in the suspended acoustical ceiling tiles with concealed piping located above the ceiling. The original plaster ceilings are located in their original condition above the suspended acoustical ceiling and protect the wood framed construction.

Sprinkler coverage was noted as providing full coverage for this building.

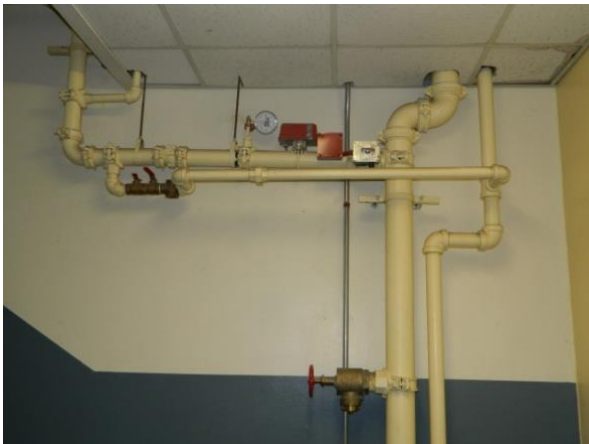
Standpipes

Class 1 combined standpipe with hose valves and floor control valves is located in the main stair 279 and a Class 1 standpipe with hose valves is located in other stair near the administrative offices. Egress stairs are compliant and the standpipe system and combined standpipe will be utilized to serve the defined sprinkler zones identified in the overall building study with the existing floor control assemblies.

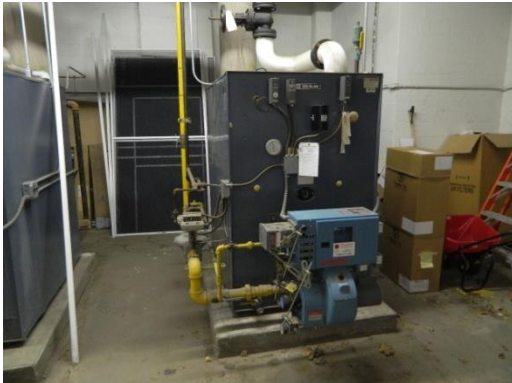
Boiler Plant

The building is served by a central gas fired gravity vented boiler plant located in the basement mechanical room. Two 1,419 MBH input Weil McLain Model 88 cast iron hot water boilers with gas fired burners were installed in 1996. The boilers feed hot water via a central pumping supply and return piping system to all unit ventilators, cabinet heaters, unit heaters, air handlers and perimeter radiation.

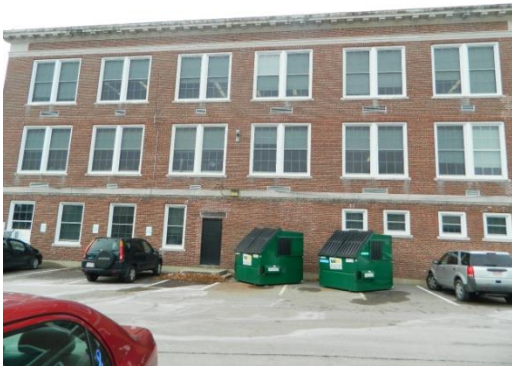
Cooling has been added via a window type air conditioning unit at the principal's office.

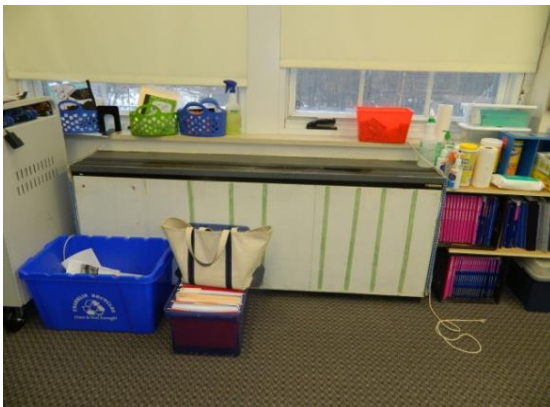
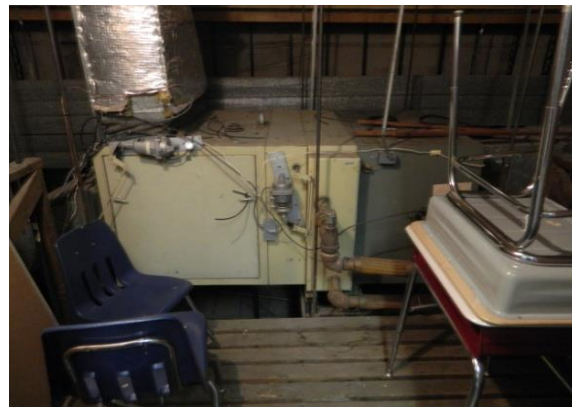
Air Side Equipment

Air handlers, AH-1 and 3, located in the mechanical rooms provide heating and ventilation air to the Library Media Center and Cafeteria. A dedicated free blow air handling unit AH-2 is located in the gymnasium. The classrooms, perimeter support spaces and perimeter offices are served by unit

ventilators. The unit ventilators have hydronic coils. Some perimeter rooms have hydronic supplemental fin tube radiation. Cabinet heaters with hydronic coils are installed at entrances, corridors and stairs.

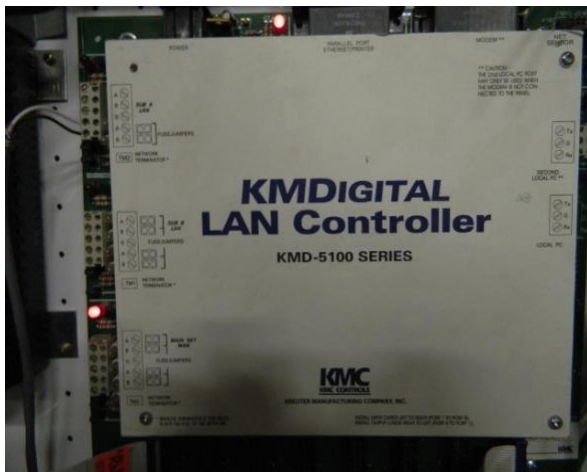
Controls

The HVAC controls are a pneumatic system. A controls system for the boiler plant and mechanical air handling equipment was installed in a recent upgrade and is via the control panel located in the basement mechanical room. The remaining HVAC equipment including unit ventilators are controlled locally via space thermostats.

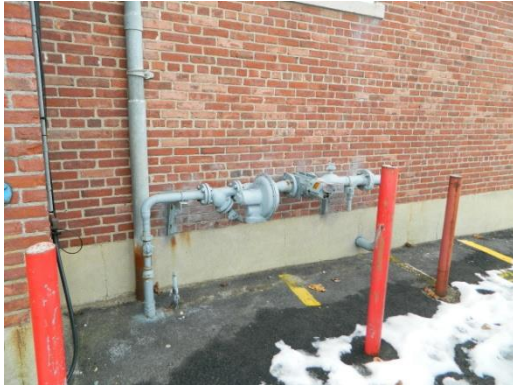
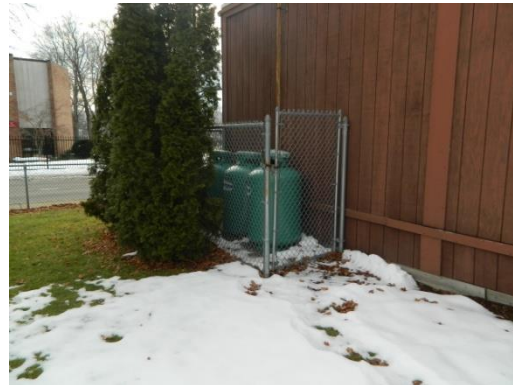
Natural Gas:

A (3") three inch natural gas main enters the basement mechanical room adjacent to the entrance stair from the exterior mounted gas utility meter and regulator. The line runs horizontally along the mechanical room ceiling and drops to the gas fired boilers and domestic hot water boiler. The gas main is fed from the gas service main located in Union Street. The natural gas distribution piping appears to be in very good condition. The existing gas service needs to be coordinated with the gas utility provider to determine if the main is adequate to supply the current and proposed requirements of the school. The portable classroom HVAC rooftops are fed with bottled propane tanks with piping exposed on the roof to the units.
