STUDY FOR THE

DAVIS THAYER ELEMENTARY SCHOOL

FRANKLIN, MASSACHUSETTS
MAY 31, 2013

KAESTLE BOOS
associates, inc

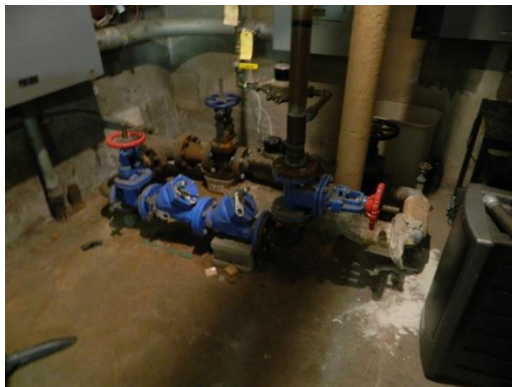
Water Service Room:

The domestic water service enters the Elec./Water service room 147 thru the concrete floor slab and transitions above the floor to a tee and horizontally above the floor to a separate floor mounted double check valve assembly control valve (old limited coverage fire service), gate valve, compound type water meter and a shut off valve on the downstream side of the meter. The domestic water piping is fully insulated from the outlet flange of the shut off valve downstream of the water meter. The fiberglass all service jacket insulation appears to be in fair to good condition.

There is a damaged insulated elbow at the base of the riser that appears to be the original insulation that has been damaged. There is a powdery material on the floor below the damage that should be tested for asbestos content. There are labels at the distribution tunnels below the school indicating asbestos materials beyond.

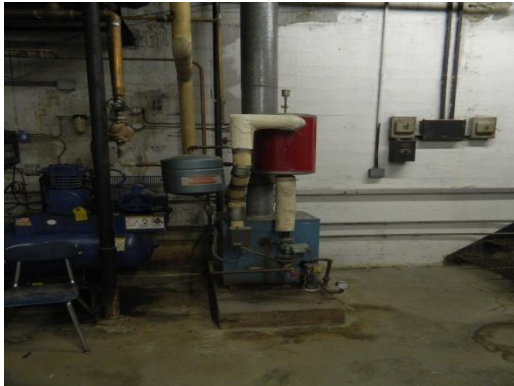
Domestic Hot Water:

Domestic hot water is generated via a Burnham 50,000 btuh gas fired gravity flue type boiler with A.O. Smith model TJV120M, 119 gallon storage tank and circulation system located in the basement Mechanical Room 144.

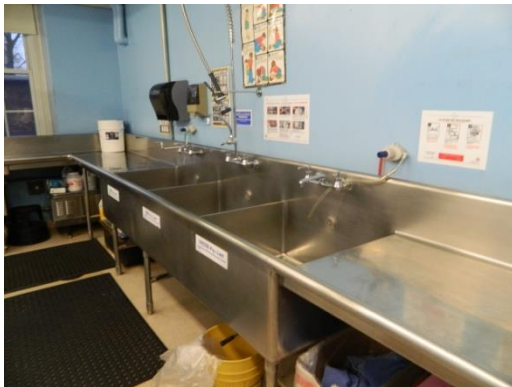
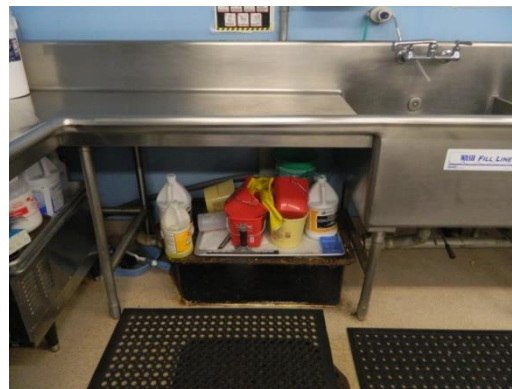
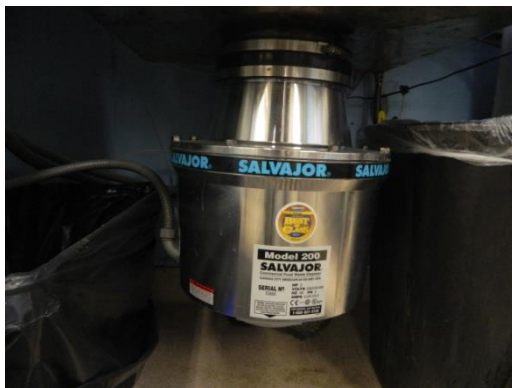
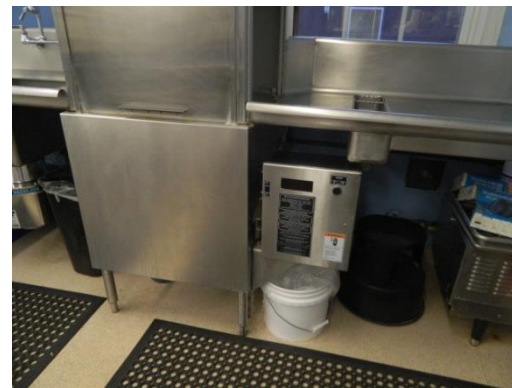
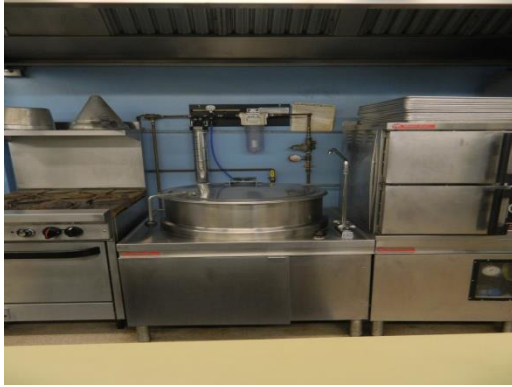
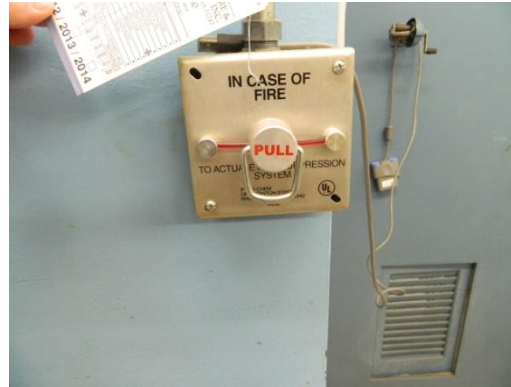
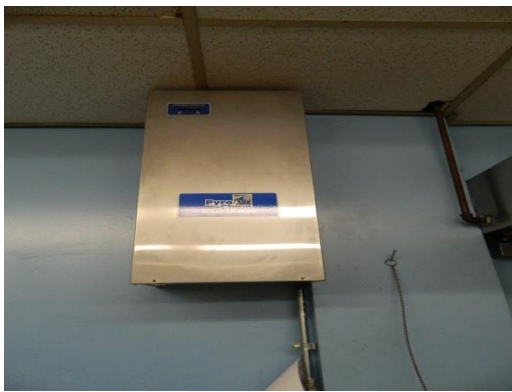
Kitchen:

The existing kitchen consists of a three well pot sink, rinse sink, disposer, dish washer, floor drain, gas fired cooking equipment, kettles, two hand wash sinks and one undersized surface grease interceptor. The domestic hot water supply appears to be at a single temperature with an electric booster at the dish washer. The gas fired equipment is located under a kitchen exhaust hood with the gas supply rising up from the floor adjacent to the hood. There is no visible master gas shut off installed. Only the three pot sink

is piped to the recessed grease interceptor. Current MA State plumbing code requires all grease generating waste with the exception of the garbage disposer to be piped to a grease interceptor, including any applicable floor drains. The floor drain does not appear to have a trap primer connection. The gas supply is also required to have an accessible master shut off, as well as a solenoid operated shut off valve with a manual reset that is controlled via a carbon monoxide sensor. The hood is supplied with a chemical fire suppression system with a nozzle located above the open flame surface of the range and includes a manual release pull station.

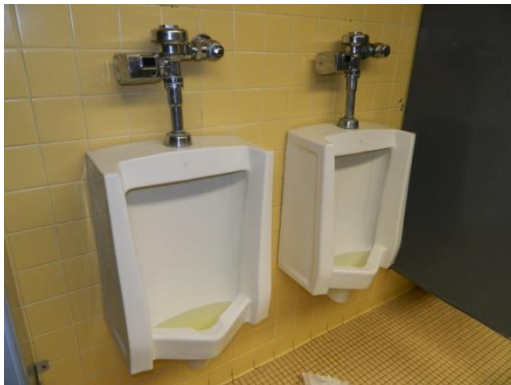
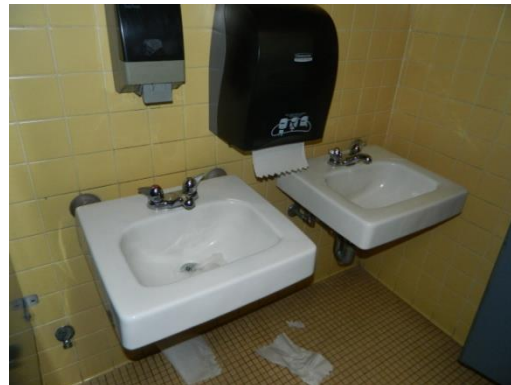
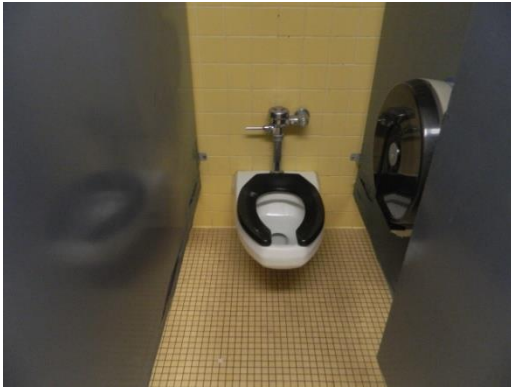
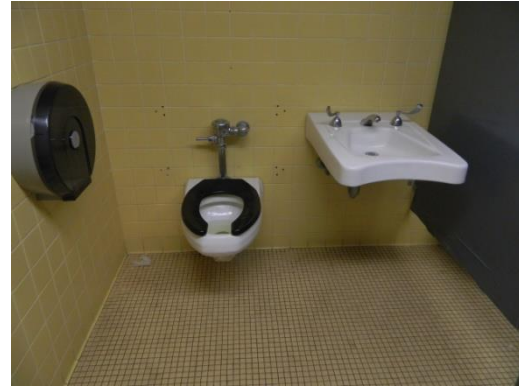
Toilet Rooms:

The toilet room fixtures are out dated and no longer code compliant and require replacement. Full ADA accessibility will be determined by the architect. The urinals and water closets incorporate manual operated flush valves while the lavatories use 4" centerset conventional controlled faucets. Some of the lavatories have been replaced with wheelchair type lavatories, but lack proper mounting height, clearance and insulation kits to be considered ADA or Massachusetts Architectural Access Barriers Board accessible compliant fixtures. All fixtures are in poor to good condition. There are water closets with wide stalls that have manual flush valves mounted on the wrong side, lacking proper clearance and grab bars to be considered accessible. There have been numerous fixture and fitting replacements over the years for upkeep and maintenance. The existing floor drains within the toilet rooms require trap primer connections to be code compliant and it is not clear at this time if they were the originally installed drains or replacements. There are no plumbing fixtures installed in the portable classrooms.

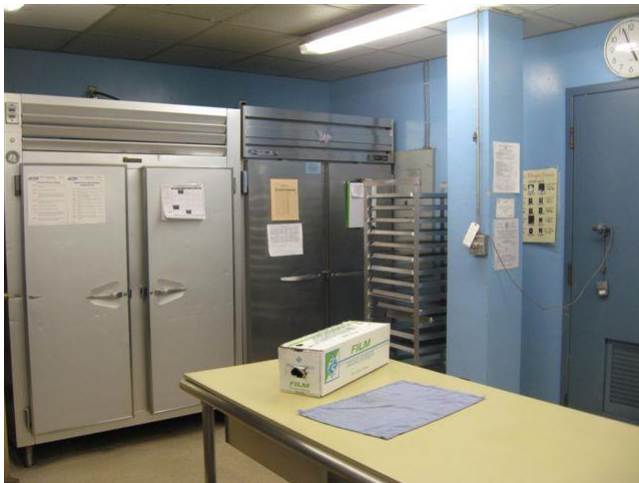
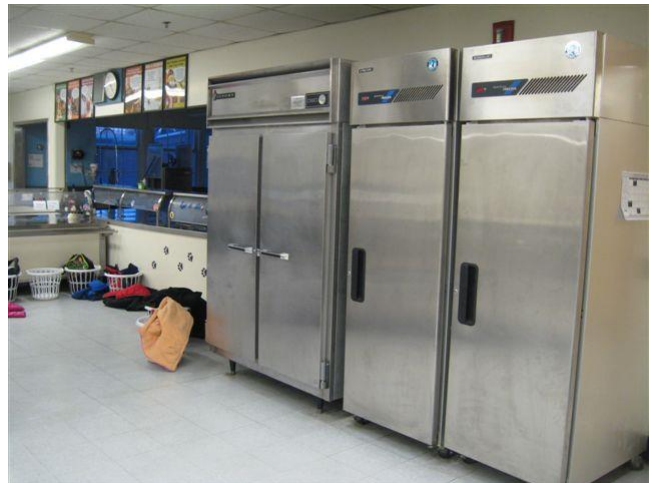
- All refrigerator and freezer storage is comprised of reach-in units and appear to be in good condition.
- Due to lack of space within the kitchen, some units are located in the Cafeteria.
- Reach-in refrigerators and freezers are generally inadequate for organized storage and handling/rotating of refrigerated foods. More frequent deliveries and short term holding are typically required due to the design and capacity of reach-in units.

At minimum, a new food service facility should be sized to accommodate any salvageable reach-in refrigerators and freezers that should be located near the receiving area and throughout the production spaces.

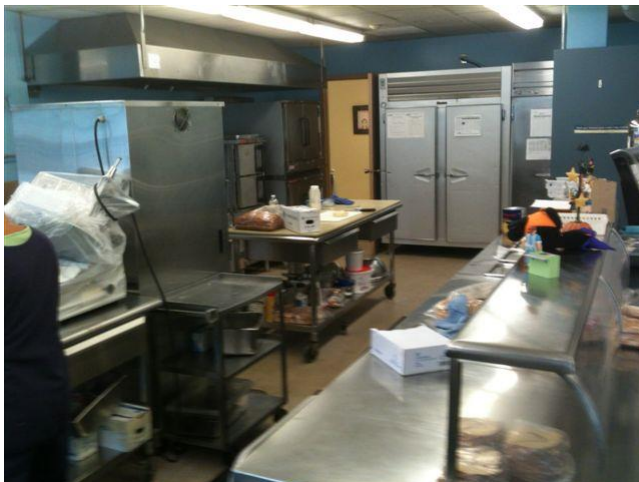
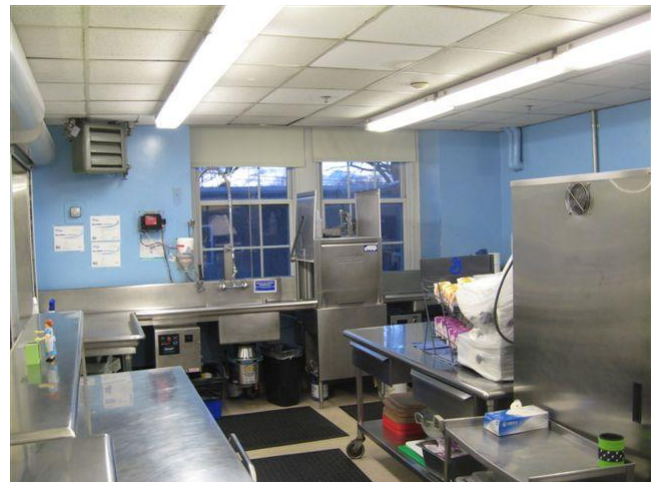
- Mobile work tables appear to be in good condition.
- There are no dedicated preparation sinks for proper separation and preparation of food products. It appears that the three-bay pot sink doubles for preparation.
- There appears to be an insufficient quantity of code mandated hand sinks or handicap accessible work stations.
- The code mandated three-bay pot sink assembly with drain-boards appears to be adequate and in good condition.
- Detergents are “stored” under both pot sink tables exposed to the preparation/cooking area and pose the risk of cross contamination. This is not code compliant.
- There are an inadequate number of floor drains to enhance housekeeping.
- Rubber mats are used throughout the food facility to prevent falls. This is unsanitary and hazardous to foot traffic.

Replace all degraded tables. Provide adequate quantity of preparation sinks, hand washing stations, worktables and food processing machinery. A new food production area should be designed to minimize labor and reduce traffic. The arrangement and selection of types of equipment will be such as to allow a maximum ease of operation, and to promote an exceptionally high degree of sanitation. Food processing machinery intended for use here will be of the competitive manufacture and will bear applicable seals of approval by N.S.F., U.L., A.S.M.E., etc.

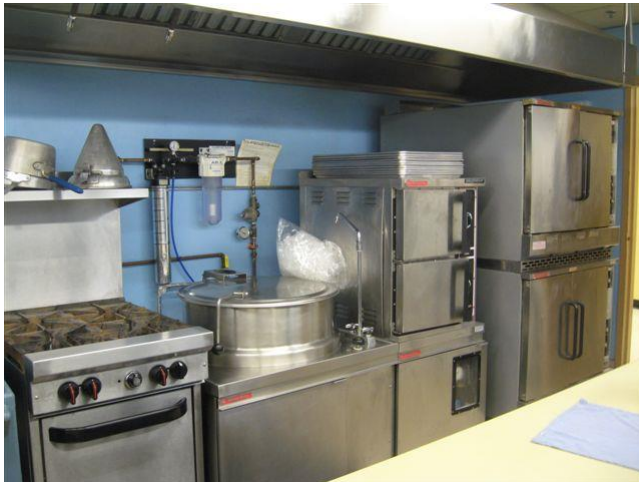
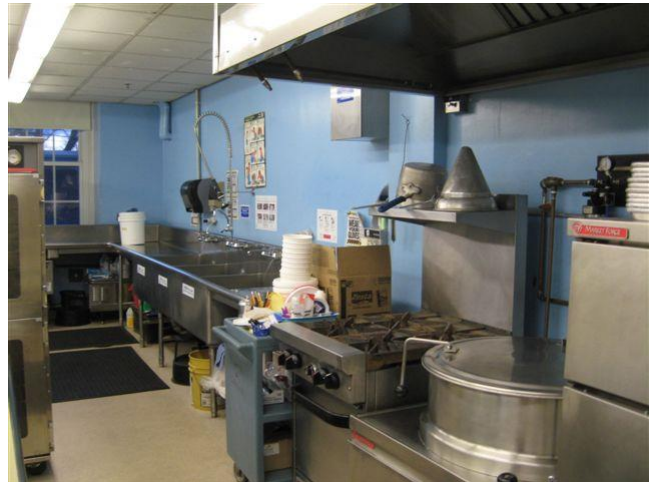
- Some of the cooking equipment appears to be antiquated and not energy efficient.
- There is minimal water capture area in the floor at the steamer and kettle battery. This situation will pose a significant hazard to foot traffic.
- Due to the limitations of the existing kitchen space, the cooking equipment is poorly arranged allowing limited access for maintenance, housekeeping and sanitation. This condition is considered unsanitary.
- Exposed piping behind the cooking equipment is unsanitary as it is difficult to access for cleaning and maintenance. This condition is considered unsanitary.

While all existing equipment will need to be evaluated with food service management and selected for re-use; quantity and type of any new energy efficient cooking equipment will be provided based on production requirements. A new cooking area should be designed to minimize labor and reduce traffic. The arrangement and selection of types of equipment will be such as to allow a maximum ease of operation, and to promote an exceptionally high degree of sanitation.

To eliminate exposed piping, we recommend a mechanical raceway be installed behind the cooking equipment. This system, which is free standing, contains the final point of mechanical connections for all adjacent items of equipment. The use of this "mechanical raceway" allows electrical, gas and water services to be brought in within vertical columnar elements to single points of connection. Quick disconnect devices for all services are located at each piece of equipment allowing ease of service, maintenance and replacement if necessary. The cost of this Utility Distribution System is off-set by a savings in primary utility service installation, final equipment connection and maintenance costs. This unit will also greatly enhance sanitation allowing ease of access for housekeeping.

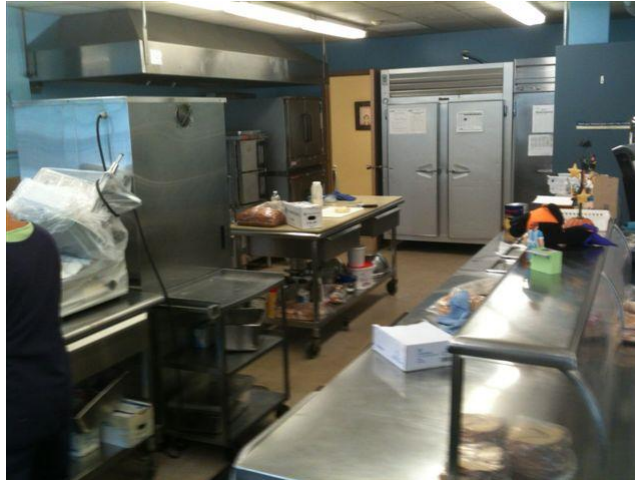
- The exhaust assembly appears to be antiquated, undersized and inefficient.
- The sloped top of exhaust hood is open to the kitchen ceiling above. This condition is considered unsanitary as it promotes the accumulation of dust and grease.

Provide a new kitchen exhaust element (over cooking equipment) that complies with current codes and standards. The exhaust hood will be of the high velocity type, fitted with grease extractor cores.

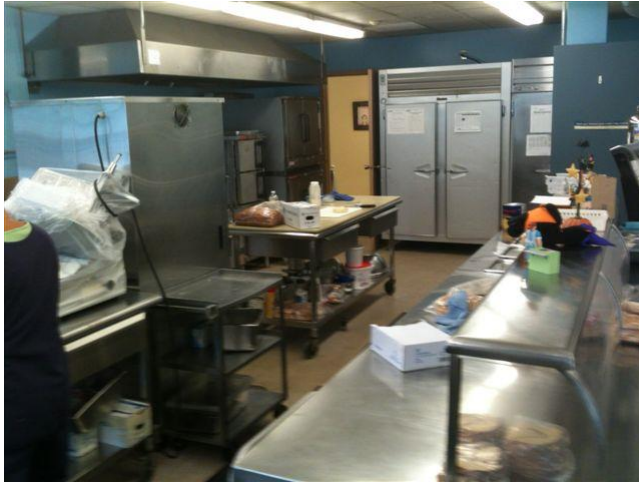
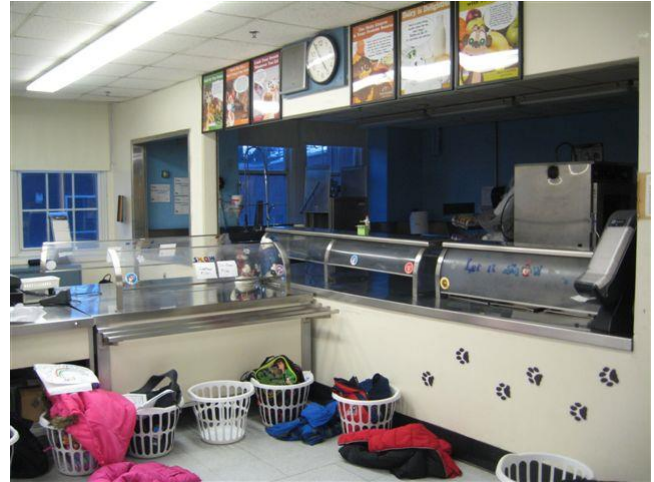
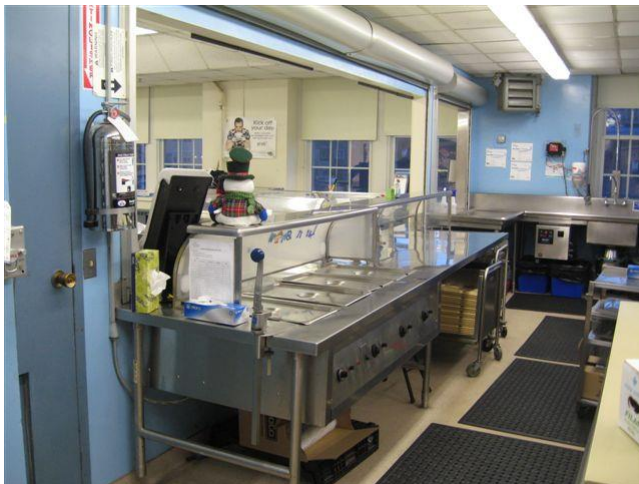
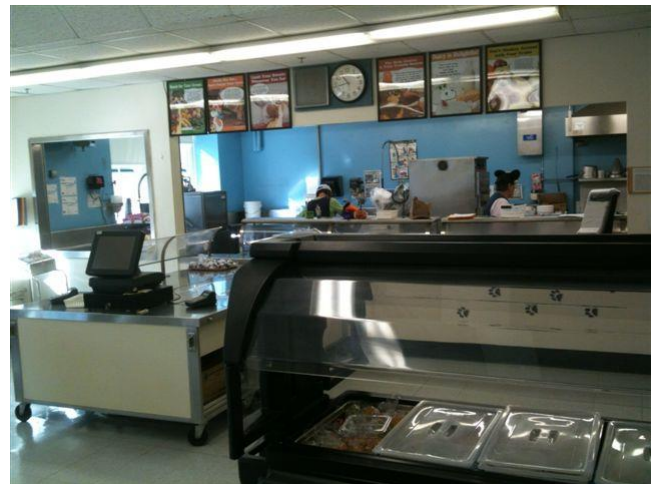
Serving Area

- The serving lines and work areas indicate extreme congestion. Cashier and multiple serving stations are located within the Cafeteria space. Traffic patterns are inefficient.
- Equipment and arrangement of the serving line/areas are antiquated.
- The serving line does not have code mandated NSF refrigerated cold food serving station.
- There are no dedicated code required hand sinks visible in this work area.
- Food protection/sneeze guards on the serving line are antiquated, in poor condition and may not comply with current NSF standards.
- Protector cases at the hot food stations appear to lack heat lamps to assist in maintaining proper temperature.
- There are no handicapped accessible work, pass-over and cashier stations.
- There is a lack of hot and cold food holding cabinets to ensure temperature maintenance.

Based on 120 meals/transactions per wave, a new Servery should be provided in a new food service facility which should provide two (2) traditional straight serving lines and a parallel “Express” line, if space allows. Two (2) cashiers are recommended.

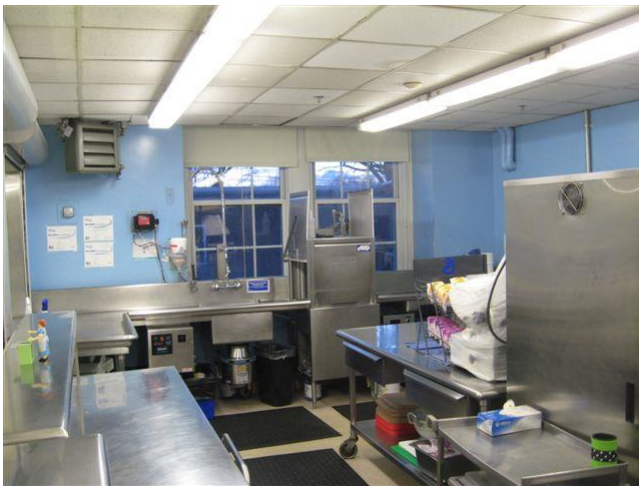
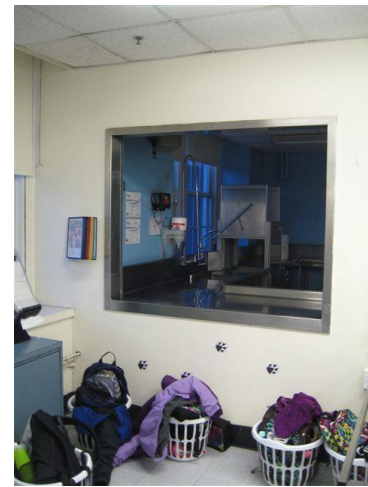
- The facility utilizes permanent trays and some disposable wares.
- Based on the current estimated number of meals per wave, the door-type dishwasher appears to satisfy current needs to clean and sanitize service trays.
- Support tables and combined three-bay pot sink assembly with drain-boards appears to be adequate and in good condition.
- There is a lack clean tray drying space.
- Some detergents are stored on the floor exposed under the soiled dish table. This is not code compliant.
- There is no condensate hood over the dish machine to capture heat and steam. This typically creates an extremely hot and wet environment.
- There is no code required hand sink visible within this area.
- All trash must pass through the kitchen and through a general corridor, which is shared with faculty and student spaces. This is unsanitary and poses a threat of cross-contamination.

Based on 120 meals/transactions per wave, a conveyor type dishwashing machine is recommended to accommodate the increased number of trays per wave as well as all kitchen wares such as 18" x 26" sheet pans and 12" x 20" cafeteria pans. The ware washing machine should be fitted with integral prewash, wash and final rinse (sanitizing) hot water booster. The soiled accumulation and scrapping areas will be designed to provide for use of the ware washing machinery at maximum capacity. Soiled tray return will be determined from design criteria. A soiled deposit window may be replaced with self-bussing to enclosed trash containers strategically located in the Cafeteria to reduce traffic at tray return window.
