**Re: Davis- Thayer Existing Conditions Report – March 21, 2023**

# DAVIS THAYER ELEMENTARY SCHOOL

## EXISTING CONDITIONS REPORT

March 21, 2023

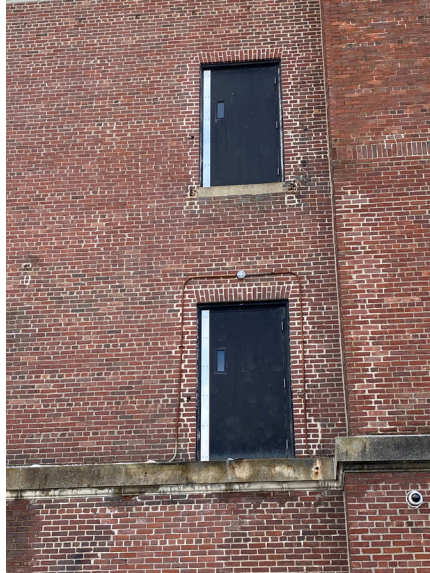
On the north side of the building, the 1973 renovation modified a row of windows to become doors leading to a fire escape. The fire escape was demolished at least 10 years ago but the doors remain and are a life safety hazard. These doors should be removed and infilled with with brick and backup CMU to match the existing construction with new windows.

- The doorways previously leading to the new demolished fire escape on the north side of the building should be infilled with masonry to match existing or infilled with new windows. The existing 'doors to nowhere' are a life safety hazard.

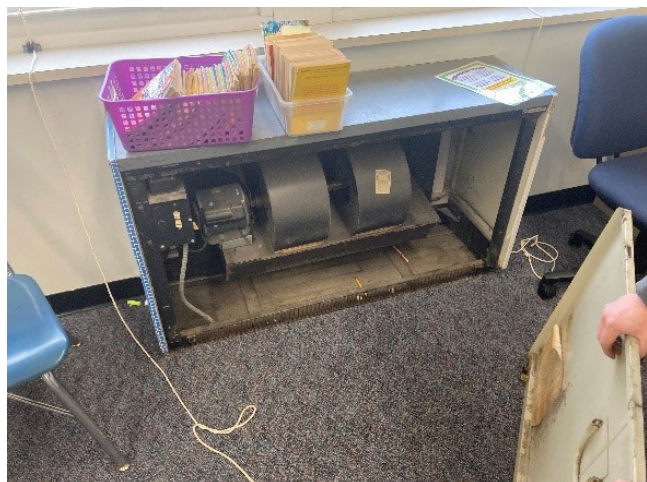
Typ. Exhaust unit ventilator

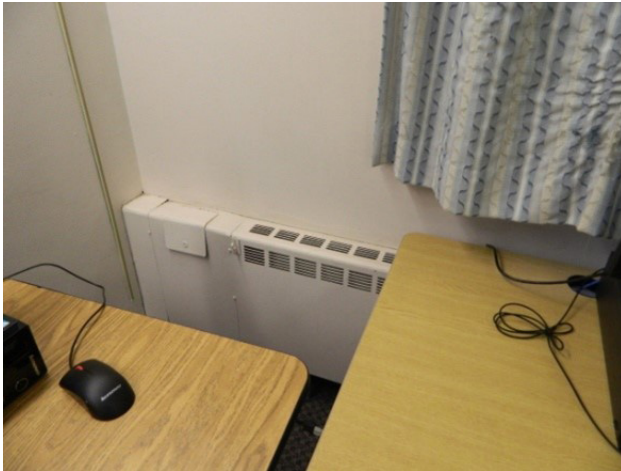
Typ. Finned-Tube radiation

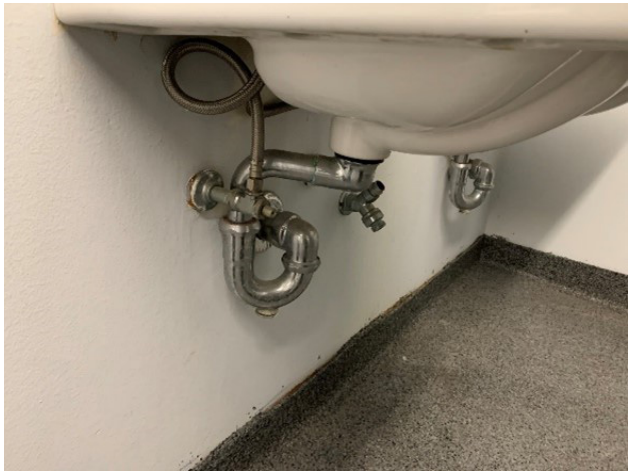
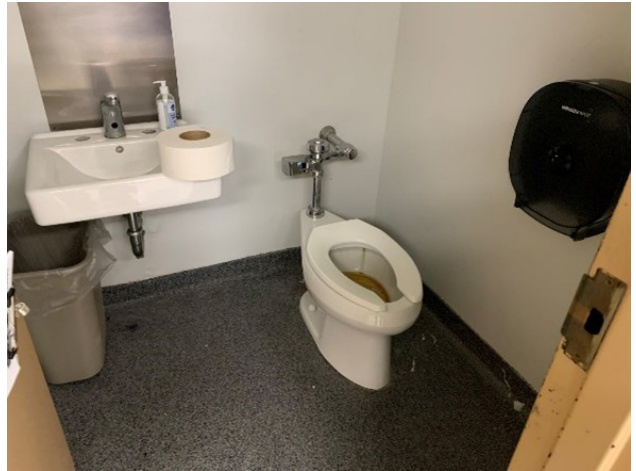
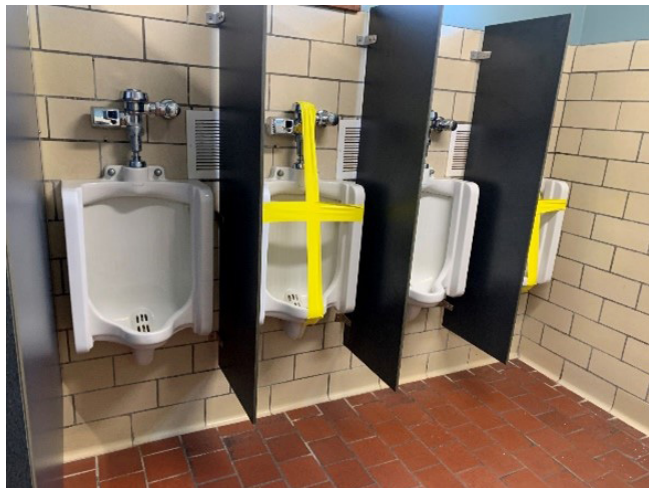
The toilet room fixtures are aged, stained and not all fully functional and most likely non code compliant. Full ADA accessibility will be determined by the architect. The urinals and water closets incorporate both manual and electronic sensor operated flush valves while the lavatories use 4" centerset conventional manual handle controlled faucets. There are some locations where the lav faucets have been updated with newer electronic sensor faucets as well. Some of the lavatories have been replaced with wheelchair type lavatories, but lack proper mounting height, clearance and insulation kits to be considered ADA or Massachusetts Architectural Access Barriers Board accessible compliant fixtures. All fixtures are in poor to good condition. There are water closets with wide stalls that have manual flush valves mounted on the wrong side, lacking proper clearance and grab bars to be considered accessible. There have been numerous fixture and fitting replacements over the years for upkeep and maintenance. The existing floor drains within the toilet rooms require replacement grids or trap primer connections to be code compliant and it is not clear at this time if they were the originally installed drains or replacements.

NV5 recommends a fully re-design or modification of all toilet rooms to bring the existing fixtures up to present code compliance. Being of low flow fixtures, non lead fixtures, proper handicap requirements / accessibility and quantities as required for the new modification to this facility. Quantities and locations of plumbing fixtures with low flow consumptions will be dependent upon the decided future building usage as per the MASS Plumbing Code requirements. At which time proper fixture mounting heights, clearances and access will be addressed to be code compliant with the Massachusetts Architectural Access Barriers Board requirements.
